## Water Intrusion in Base/Subgrade Materials at Bridge Ends

Project 0-5096 research included an extensive literature review to determine all possible sources of water intrusion at bridge ends. Several state departments of

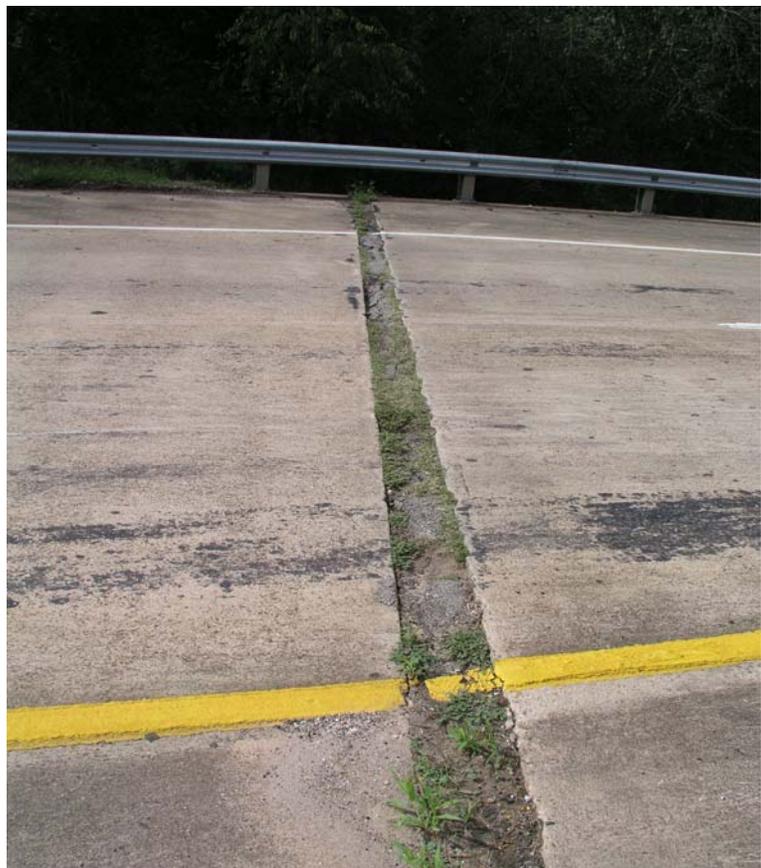
**Figure 2. Poorly Maintained 5-inch Wide Joint Between Bridge Deck and Approach Slab.**

Joints between the approach slab and the bridge, bridge wings, or pavement surface must be properly sealed. It is

imperative that the joints be periodically maintained to remove debris and ensure proper sealing. Other preventive maintenance techniques that show considerable promise are: (a) slab stabilization (or undersealing) for controlling void development underneath the approach slab and concrete pavement, and (b) cross-stitching and slot stitching for controlling further development of any cracks that appear in the approach slab and concrete pavement.

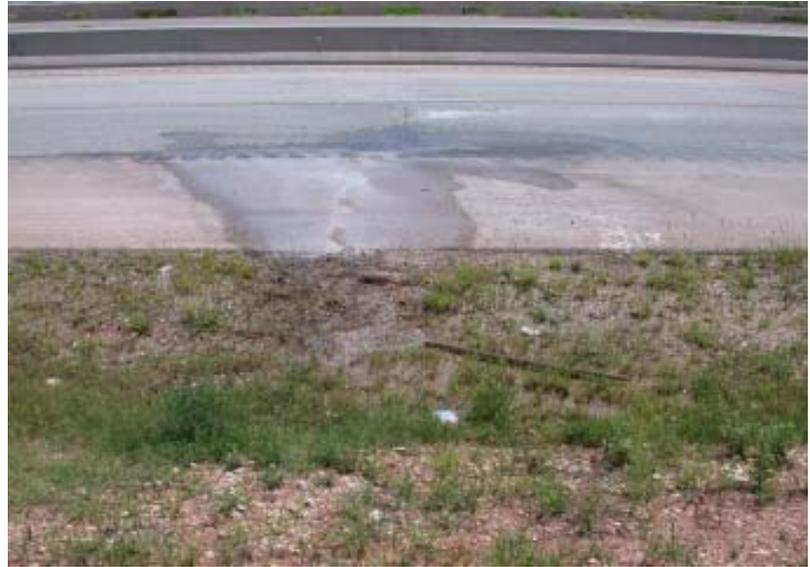
**Figure 3. Water Seepage at the US-83 Overpass Bridge Departure Over Antilley Road in Abilene District.**

A detailed design of a repair and installation of an underdrain should be accomplished for the US 83 overpass of Antilley Road in Abilene. The underdrain design should be similar to the detail provided by the Tyler District.

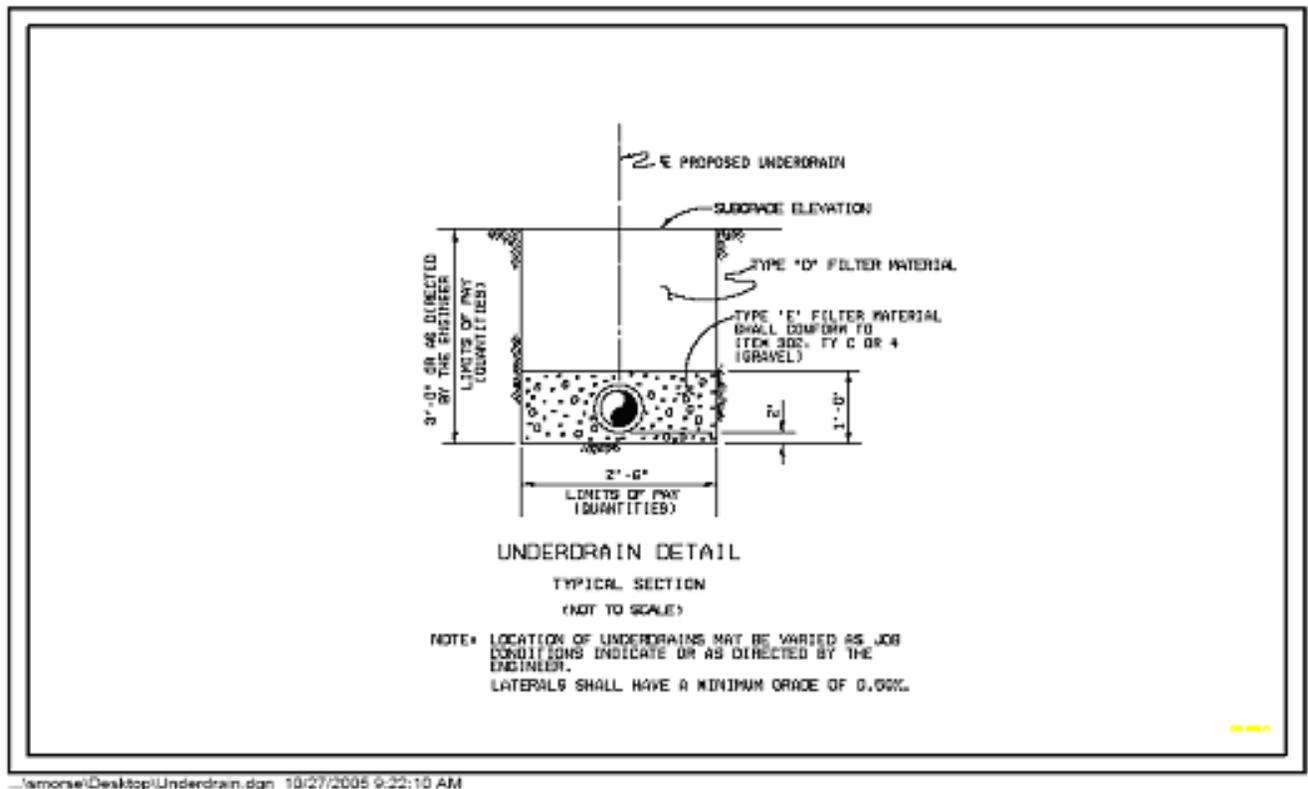
**Figure 4. Tyler District Underdrain Detail.**
