# Limitations of Spacecraft Redundancy: A Case Study Analysis

Robert P. Ocampo<sup>1</sup>

University of Colorado Boulder, Boulder, CO, 80309

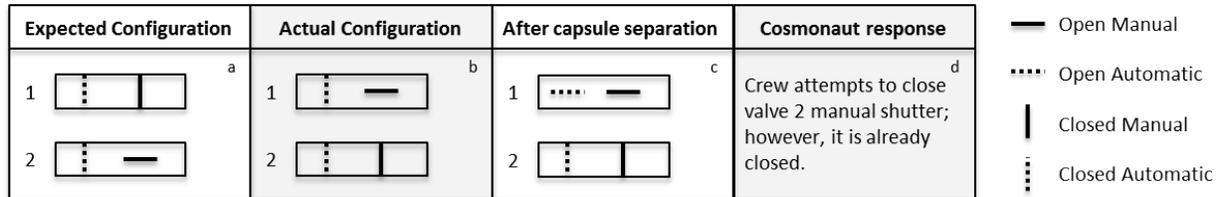
At the time of the disaster, Soyuz employed two redundant pressure relief valves in its capsule design (see Fig. 1a). Although only one valve was necessary to equalize cabin pressure during re-entry, Soyuz 11 flew with two pressure relief valves to ensure fresh air was available to the crew in the event the capsule landed in water<sup>11</sup>. Both valves had two shutters—one which operated manually, and one which opened automatically after the deployment of the main parachute. The shutters were placed in series so that capsule depressurization through a given valve would only occur if *both* shutters were open (Fig. 1a).

Nominal procedures called for three of the four shutters to be set closed prior to launch: both shutters in valve 1, and the automatic shutter in valve 2 (with the manual shutter in valve 2 left open—see Fig. 1a). However, during valve installation, the two valves were inadvertently switched, leaving all shutters closed except for the manual shutter in valve 1<sup>11</sup> (Fig. 1b).

**Figure 1. Soyuz 11 expected and actual depressurization valve configuration.** (a) Soyuz 11 pressure relief valves in their expected pre-launch configuration. On valve 1, both manual and automatic shutters were supposed to be closed; on valve 2, only the automatic shutter was supposed to be closed. (b) Due to incorrect valve installation, valves 1 and 2 were switched: valve 2 had both shutters closed, while only the automatic shutter on valve 1 was closed. (c) Capsule separation triggered the automatic shutter in valve 1 to open. This created an open path between the cabin and the external environment, leading to cabin depressurization. (d) Because the crew believed the valves were in their expected configuration, they attempted to close the manual shutter on valve 2. This was the proper response given the system’s expected configuration. However, because the valves were switched, this action was ineffective; the crew spent their final minutes trying to close a valve that was already closed.

During reentry, capsule separation inadvertently triggered the automatic shutter in valve 1 to open, thereby creating an open path between the cabin and the external vacuum. The cosmonauts, *not knowing the two valves had been switched*, assumed the automatic shutter in valve 2 had been breached, and attempted to close it manually<sup>11,12</sup> (Fig. 2d). Given the cosmonaut’s knowledge of the *nominal* valve configuration, this was the appropriate response. However, because the two valves had been switched, the crew spent their final seconds trying to manually close a valve *that was already closed*.

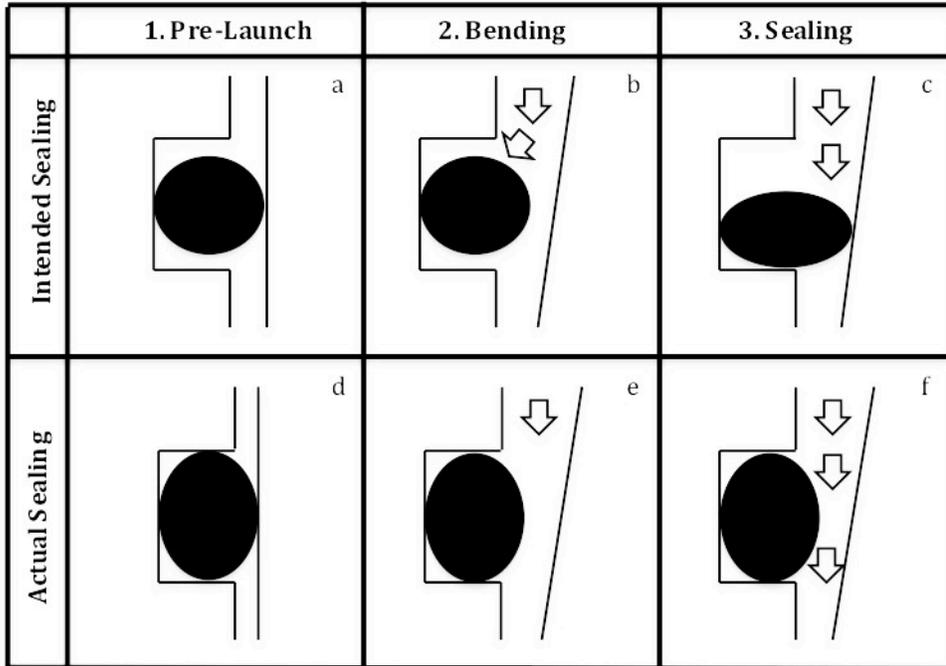
Each SRB was comprised of seven segments connected by pins at tang and clevis joints. Two O-rings—one primary, and one secondary—were positioned in series within the joint so as to maintain a gastight seal between segments (Fig. 2a). During ignition, SRB bending (known within NASA as “joint rotation”) increased the gap between tang and clevis. During this transient time period, joint sealing was nominally<sup>3</sup> maintained through pressure actuation—a process whereby combustion gases extruded the O-ring in to the gap<sup>13,15,16</sup> (Fig 2b-2c).

On STS-51-L, primary O-ring sealing was precluded for two reasons: 1) a smaller than normal pre-launch gap between tang and clevis, resulting from an “out-of-round” SRB segment, eliminated the requisite spacing between O-ring and upstream wall (Fig. 2d). This prevented combustion gases from getting behind the O-ring and initiating sealing during joint rotation<sup>13</sup> (Fig. 2e-2f). In addition, extreme cold at launch (estimated to be  $28 \pm 5^\circ$  F at the joint) significantly compromised the resiliency of the rubber O-ring, thereby further reducing the rate at which the O-ring could expand into its seat<sup>13</sup>.

The secondary O-ring proved ineffective as a redundant backup, as joint rotation, coupled with the extreme cold, prevented it from effectively sealing the joint. Aluminum oxides, a by-product of the burned SRB propellant, managed to temporarily seal the joint during liftoff, preventing a launch pad catastrophe; however severe wind shear at T +37 seconds destroyed this temporary seal<sup>13</sup>, leading to the eventual aerodynamic destruction of the vehicle.

**Figure 2. Intended and Actual Sealing Characteristics of SRB O-rings.** Ideally, the O-ring should be seated so that neither the upstream nor downstream wall is touching (a). When joint bending occurs, this configuration allows combustion gases to get behind the O-ring (b), sealing the joint through pressure actuation (c). The leaking joint on STS-51-L was out of round, causing the O-ring to compress and touch the upstream wall (d). Because of this compression, combustion gases could not get behind the O-ring to initiate sealing during joint bending. Furthermore, cold weather at launch reduced O-ring resiliency, thereby allowing the combustion gases to breach the joint.
