WPA Mk I: On orbit and on ground investigations and refurbishment activities

This paper describes the flux of on orbit and on ground investigations that have involved the Water Pump Assembly (WPA) Mk I, from the issue detection to the identification of the subsystem involved, until the detailed investigation of the causes and the WPA refurbishment and re-acceptance.

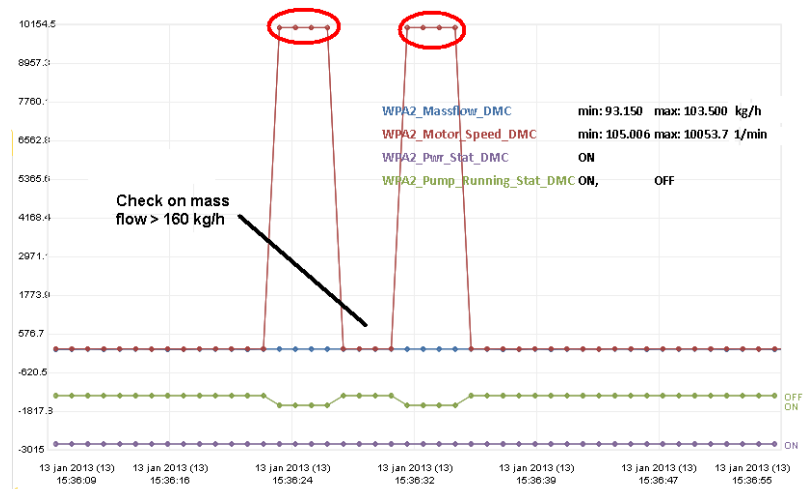
Figure 2: Anomalous WPU motor speed behavior

Telemetries analyses showed that the Water Pump Unit (WPU) did not start running after two “run” commands included in the pump switchover automatic procedure. Upon reception of “run” command the WPA software performs the following motor start up sequence: if the motor does not reach the expected speed (i.e. minimum rump up speed of 1600 rpm) the startup sequence is repeated until a maximum of three times (see Figure 2). If the motor starts successfully, the plenum inlet temperature control is activated (see Figure 3). At the beginning of the startup sequence the validity status of WPA telemetries is not valid, so a dummy value for the WPA telemetries is automatically generated by the Data Management System (DMS). The red circled in Figure 2 and Figure 3 show the spikes corresponding to the dummy values generated by DMS

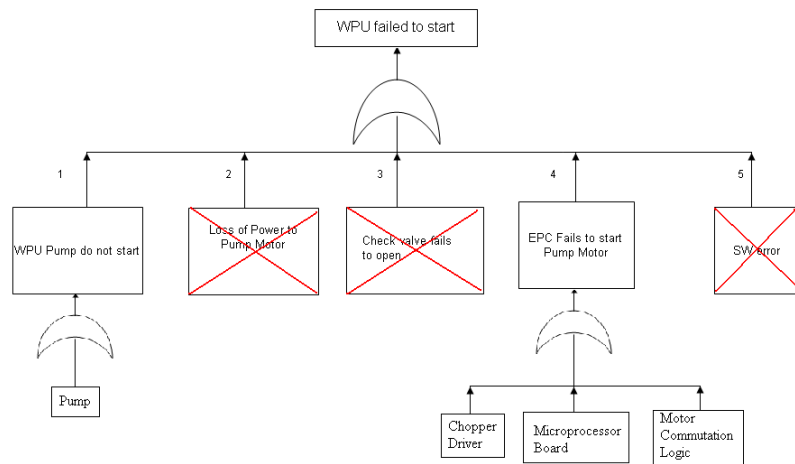
Figure 4: WPA Failure Tree

Finally the failure was identified as electrical and located in the EPC or in the WPU (electric motor, see Figure 4). No failure isolation at EPC or WPU level was possible, so Engineering recommended the WPA2 download for the following reasons:

1. Hydraulic failure
2. Software failure during the stepper phase
3. EPC failure (e.g. Chopper Driver, Microprocessor Board, Motor Commutation Logic)
4. WPU failure (e.g. loss of motor drive due to open circuit or pump jamming)
5. Internal connector powering WPU failure

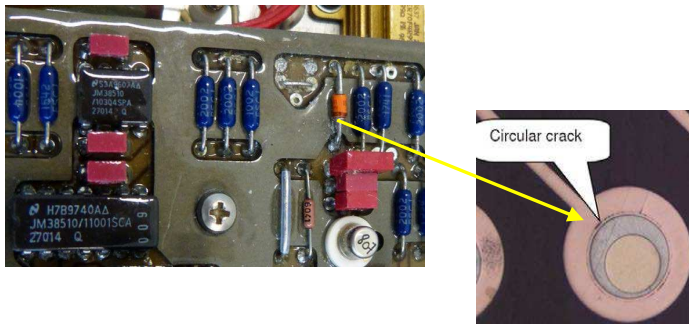
Figure 10: circular crack near CR5/cathode

The FM Chopper Driver was firstly studied with the use of X-ray investigation. This method allowed to discover a disconnection on the current regulator circuit that blocked the signal for the step down converter which delivers the supply voltage to the pump motor. One circular crack near a cathode was the most possible root cause for this disconnection (see Figure 10).

restore the lost functionality. Moreover, no indication for damage or overstress of other parts on this board has been found. No other FM boards were affected by a failure.

On this base, it was agreed to put an additional connection via an additional wire in order to

On the base of above inspection, test and analysis, finally the following reworks have been implemented in the chopper boards FM and spare. For the Chopper board FM, it has been reworked, restoring the interrupted path by a wire connected between CR5-cathode and LK3 jumper. To restore the connection by the external wire it was: dismantled the Printed Circuit Board (PCB) from mechanical frame; performed visual inspection in order to verify the possibility to connect the wire to the lead of the diode at the bottom side of the PCB according to the Flight rework rules; connected the wire; performed visual inspection on all soldering; performed the local coating treatment and check again the functionality of the chopper board. For the Chopper board spare, it has been reworked exchanging R45 with R59 and replacing R46 from 750Ω to 499Ω.

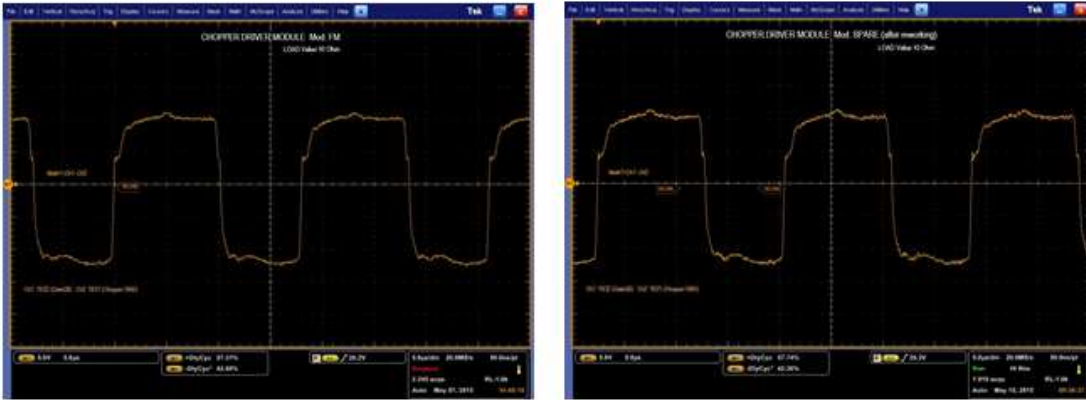
Figure 11: FM and Spare Chopper Board Voltage Behaviors

These tests have shown that after reworking the chopper boards FM and spare have the same behavior. Voltages measured along low voltage level circuit at open loop are quite identical between both boards (see **Error! Reference source not found.**). So also for the high voltage circuit in the closed loop. Both boards could be mounted on the WPA EPC FM for final acceptance test after board repair. However, the Material Review Board (MRB) has directed to mount the spare Chopper Board on the WPA FM2 Mk I. The EPC Integration of Chopper Board spare was then performed and the functional/electrical test outcome was that the WPA Mk1 worked correctly after the refurbishment.

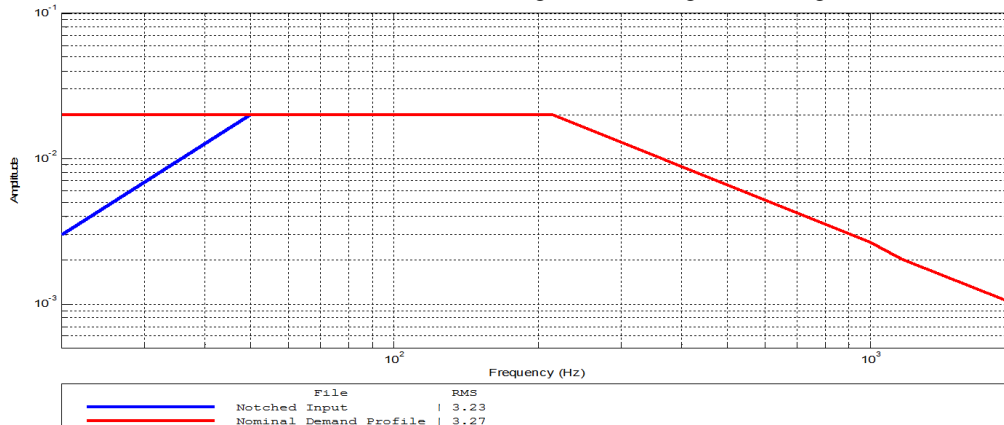
Figure 14: Test results

The WPA re-acceptance vibration test campaign results was considered successfully performed. Even if in the frequency range 20-50 Hz a manual notching was applied for all the three directions X-Y-Z, the input profile overall acceleration was in line with the nominal value (3.23 grms vs. 3.27 grms, see Figure 14).
