Coolant Leak from ISS External Active Thermal Control System (EATCS) – An Examination of Most Probable

Darnell T. Cowan¹, Timothy A. Bond²

NASA Lyndon B. Johnson Space Center, Houston, TX, 77058

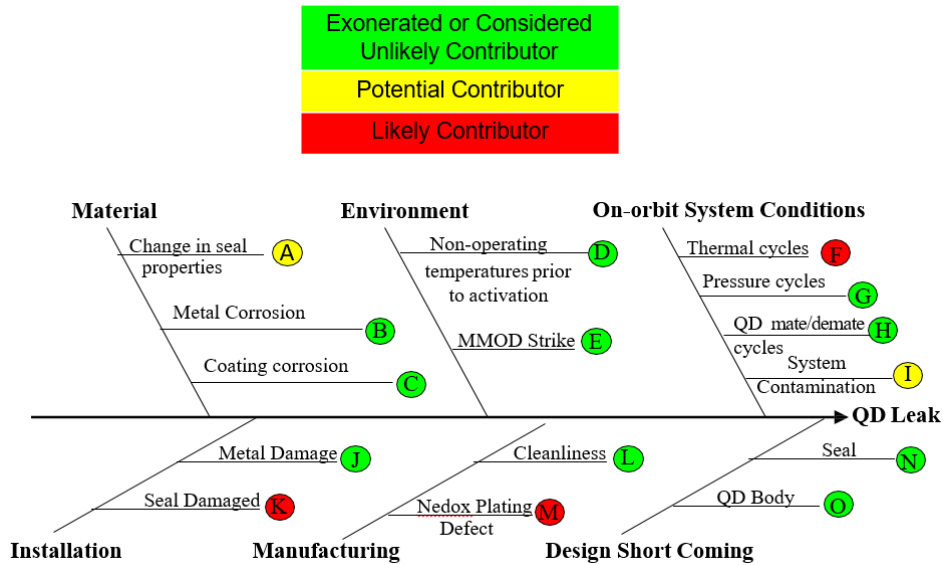
NASA partnered with the ISS prime contractor, Boeing, and the QD manufacture, Parker Stratoflex, to determine the most probable root cause of the QD leak. A fishbone type diagram was created to list the potential contributors to the leak as shown in Figure 3, and the failure investigation involved assessing each of the potential contributors through visual inspection, chemical evaluations, nondestructive evaluation (NDE), and destructive evaluations. First the QDs were disassembled by Parker Stratoflex, then inspected by the naked eye and under magnification using a borescope and a stereo microscope. Material samples were then taken by NASA Johnson Space Center (JSC) and Boeing Huntsville Materials and Process (M&P) labs and evaluated using Energy Dispersive X-Ray Spectroscopy (EDS), Fourier Transform Infrared (FT-IR) and Computerized Tomography (CT) scanning to see what information could be gained.

Figure 3. Fishbone Diagram of Potential Contributors to the QD leak

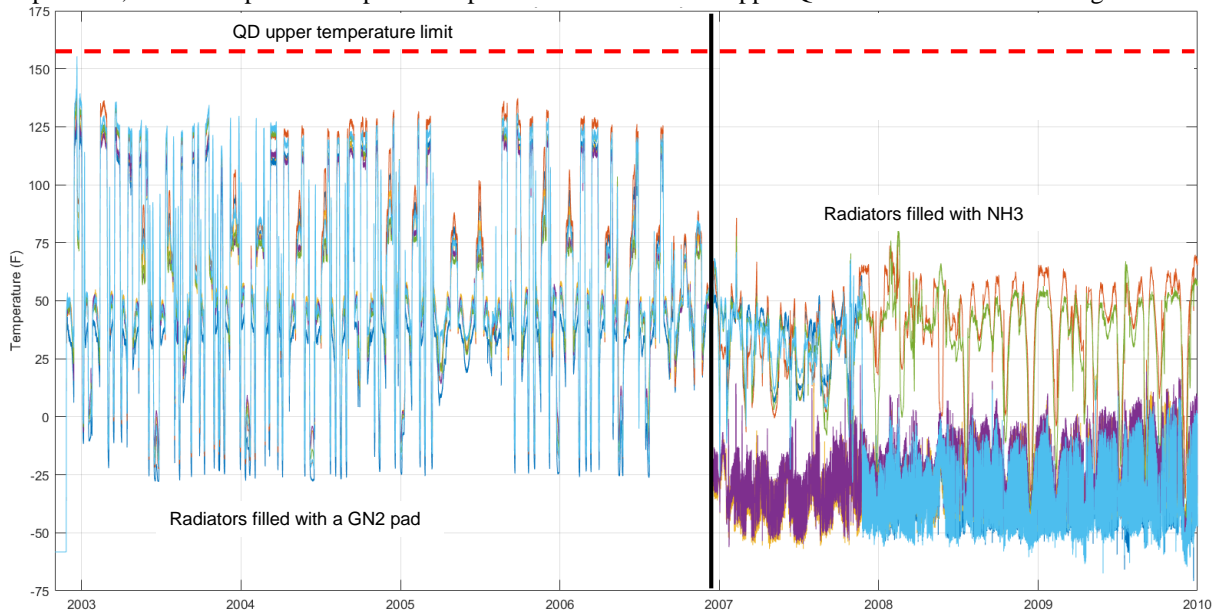
However, this was not observed from the imagery inspections or chemical evaluations. Prior to when the radiators were filled with ammonia and the EATCS were activated in 2006, all the radiator jumpers and QDs contained a GN₂ pad pressure, and the exposure temperatures predicted to be near the upper QD limit as shown in the Figure 4. These

Figure 4. Temperatures from each of the P1 EATCS radiators. Radiators were filled with GN₂ until Mid-2006 then filled with ammonia and activated.

temperatures were expected due to the vehicle configuration and orientation, empty flowpath conditions, and fluid properties unlike when the system is in operation with flowing ammonia. Similarly, the QDs were also exposed to wider pressure variations during this time since the pressure change is directly proportional to the temperature changes, but a telemetry review concluded that the pressures and temperatures were within limits. Thus, it's unlikely that pressure and temperatures variations alone would cause any damage to the QDs.

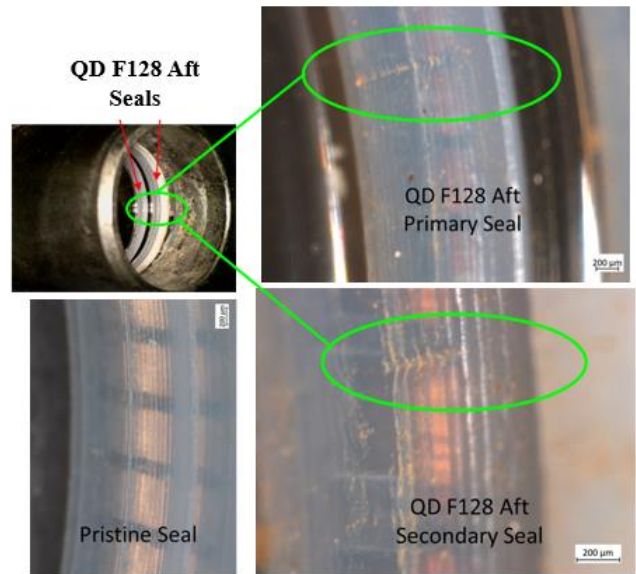
As mentioned earlier, a calibrated leak test found the highest leakage occurred near the aft seals on QD F128¹, and there are primary and secondary seals located on the forward and aft end of the QD as shown in Figure 6 and 5, respectively. After the QD was disassembled, stereo microscopic images found what appeared to be a probable damage, or defect, on both aft seals on QD F128, and the defect goes across the seal in the direction that would allow ammonia to leak to the outside environment as shown in Figure 5. This type of defect has been observed during ground inspections post seal installations on other QDs while the QD is being assembled at the manufacturer and are typically replaced at that time prior to final factory testing. A pristine seal would not have this defect as shown in Figure 5, and this defect was not observed on any of the other seals in QD F128 or F140.

Installation of this style of seal is difficult to accomplish and it is not uncommon that multiple seals are consumed before a and successful installation. Typically, the QD would fail the leakage required during acceptance testing if any defects are missed during seal inspection. Processing records show that QD F128 did fail the leakage requirement during final leak testing before launch but passed all Parker factory testing originally. The QD passed the leakage requirement after the primary and secondary forward seals were replaced and was accepted for launch. However, this leak test included the entire QD and all seals, since the aft seals cannot be individually leak tested as mentioned earlier, which is an accepted risk for all QDs.

Ammonia would have to breach the primary and secondary aft seals to leak out to space. Since the calibrated leak test during the failure investigation showed the highest leakage coming from the aft seals, the failure assessment team hypothesized that at least one of the two aft seals was performing well after final testing prior to launch. The other seal could have been leaking undetected, but still pass the leakage test. Therefore, the leading theory is that the aft seal defect was a likely a contributor to the leak of QD F128.

Figure 5. QD F128 Aft Seals Defect Compared to a pristine Seal (QD).

1. The primary and secondary aft seals of QD F128 were possibly damaged during original installation, and potentially the primary seal may never have sealed properly. The secondary seal may have sealed acceptably during the first five years of service, but later began to degrade.

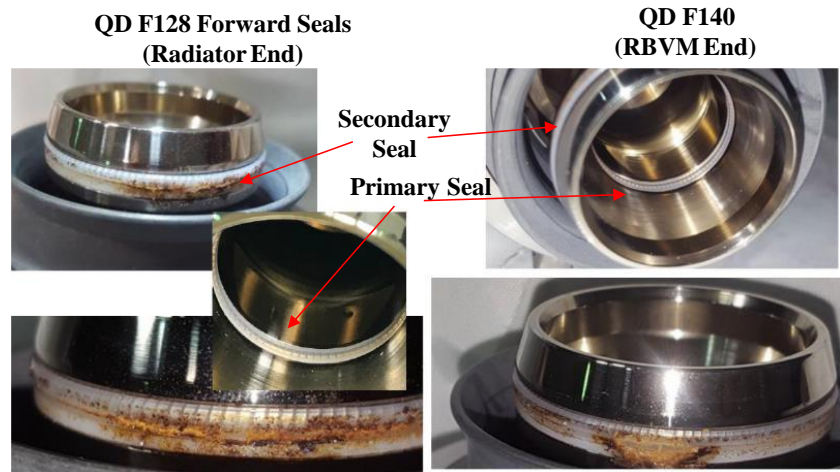
Visual inspections of QD parts were conducted at various stages of the failure investigation, and brown NVR¹ on the forward secondary seals on both QD F128 and F140 were observed after the jumpers were returned the ground as shown in Figure 6. Samples of the NVR was chemically evaluated, and the results found the constituents and quantity to be as typically expected, and generally within the allowable limits per the ammonia purity specification¹. The presence of NVR on the seals were expected because the ammonia vaporizes as it passes through the leak path and into a vacuum leaving behind residue. Past observations and testing have shown that NVR can be deposited on and adhere to cold surfaces preferentially. Radiator jumper QDs are exposed to typically -40 to 0 Deg F (-40 to -18 Deg C) temperatures while in service on-orbit, which is cold enough for the NVR to deposit on surfaces downstream of leak sites and seals which is consistent with what was observed. Over time this process continued resulting in a significant quantity of deposits, continuing until the leak was stopped by venting the ammonia from the radiator flow path and jumpers.

The NVR deposits alone were likely not enough to have induced a leak path but cycling the QD with the NVR on the seal surfaces could do so. Though pristine QDs were installed on the refurbished return jumper, it is expected that the sealing surfaces on the RBVM and radiator QDs that mate to new pristine female QDs on the jumper may contain the NVR deposits also. This could be an issue when the refurbished return jumper is reinstalled as installation requires cycling the QDs, and the seals on the pristine female QDs on the return jumper would slide across the sealing surfaces on male QDs that may have NVR on surfaces. Contact between the new QD seals on the refurbished jumpers and male surfaces with deposits may result in damage and could introduce a new leak path. Conceptually, wetting the sealing surfaces on the RBVM and radiator QDs with ammonia should redissolve the NVR back into solution and reduce risk of damage, but only if this could be achieved after installing the refurbished jumpers, and before cycling the QDs.

Figure 6. Brown NVR shown on the QD F128 and F140 Secondary Aft Seals

This technique would have to be performed during the EVA to install the refurbished jumpers, and the amount of time for NVR to redissolve would be limited. To evaluate feasibility, the failure investigation team performed an ammonia immersion test on samples from the leaky QDs to determine if the deposits would dissolve back into solution and how long that would require. The test included soaking the disassembled QD F128 with ammonia for increasing durations, with and without agitation. Unfortunately, it was found that the NVR was not readily dissolvable and would take several hours to completely dissolve back into solution, which is longer than the amount of time available to perform during the EVA to install the refurbished jumpers. Therefore, wetting male QDs during the EVA would not be beneficial, and the risk of possibly introducing a new leak path was accepted due to the low likelihood and based on engineering judgement.

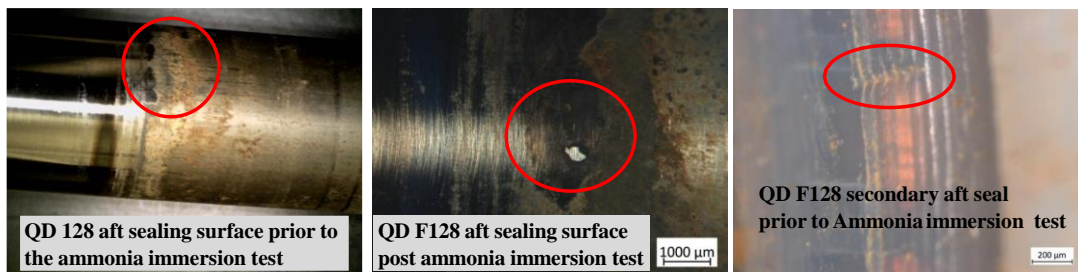
Stereo microscope imagery was performed on the leaky F128 QD following the ammonia immersion test, and Nedox plating delamination and pitting was found on aft sealing surfaces. Delamination wasn't observed prior to the ammonia immersion as it was hidden under areas with NVR, and some locations appeared to align with the location of defect found on the aft secondary seal as shown in Figure 7. The consequences of Nedox delamination could be to produce a path for ammonia to leak to space especially if it's located underneath a seal. Therefore, this was considered a likely a contributor to the QD leak. Nedox adhesion issues were observed during ground acceptance testing of two similar radiator return QDs prior to flight and were from the same manufacturing lot as the leaky QD F128, and all the other radiator return QDs in service on-orbit, and five ground spares.

In 2000, Boeing M&P led an evaluation of the delamination issue with the vendor, Parker Stratoflex, and determined that the likely cause of the adhesion issues was due to contamination of surfaces on a few components during plating. At the time, the experts believed this issue was not fleet wide because it should be detected during acceptance testing or inspections during preparation for flight. The two QDs with the Nedox adhesion issue were scrapped, and the other radiator jumper QDs, including F128, were launched based on inspections that were

Figure 7. QD F128 sealing surface prior (left image) and after (middle image) of the ammonia immersion test. Defect found on the aft seal (right image) coincides with delaminated area (middle image)

performed. The corrective actions at the time for plating issues led to the modifications of the plating process to reduce the likelihood of causing this issue for future QDs, but it is possible that Nedox adhesion issues were present on the leaky QD F128 and had gone undetected until the delamination started to occur while in service on-orbit. Therefore, it is considered likely that Nedox delamination contributed to the QD F128 leak.

2. Over time and with thermal cycling, an area of Nedox plating very near or under the secondary aft seal of QD F128 failed and became delaminated, probably beginning with a small crack in the coating.

1. Continue with the current sparing posture of the ISS radiators jumpers, which is to assemble and launch new jumpers as needed.
2. Install the refurbished radiator jumpers, monitor for ammonia leaks, and perform corrective actions if necessary.
3. Continue using the current QD design with the adjusted Nedox plating process for future QDs.

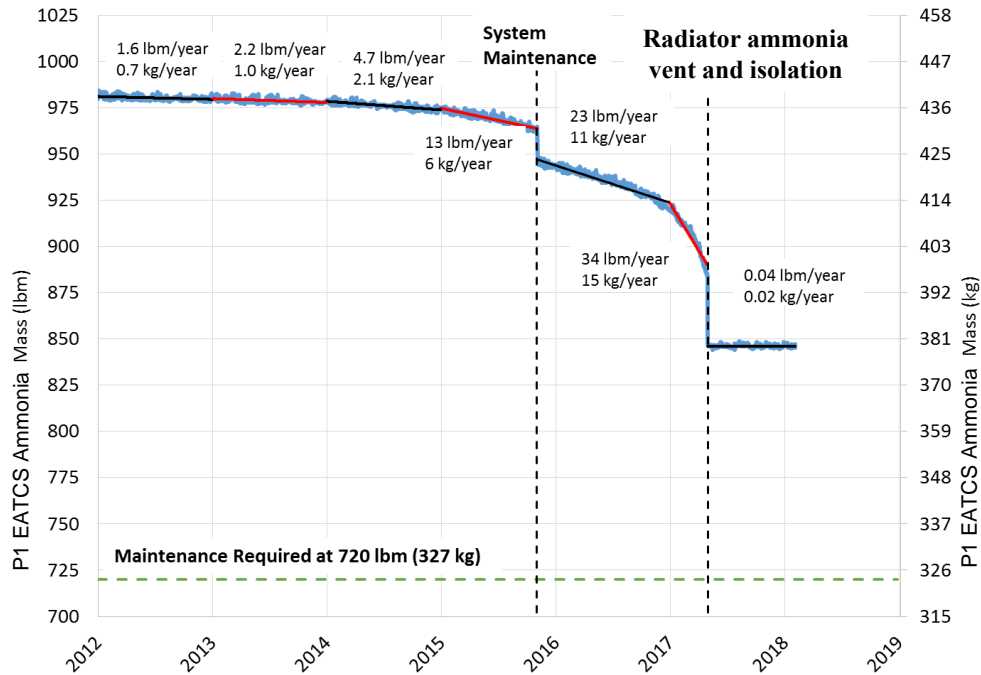
As discussed earlier, the typical on-orbit operating temperature of the ammonia flowing through all the radiator return jumper QDs range from -40 to 0 Deg F (40 to -18 Deg C). While this is well within the design limits for QDs of -100 and 155 Deg F (-73 and 68 Deg C), thermal cycling of this magnitude could aggravate the Nedox plating issues found on QD F128 ultimately resulting in delamination and failure of the coating under seals. This is considered a likely contributor to why the P1 EATCS ammonia leak accelerated over time while QD F128 was in service on-orbit, prior to venting of ammonia from the radiator flowpath in 2017 as shown in Figure 8.

Figure 8. P1 EATCS Calculated Ammonia Mass and leak rates from 2012 to 2018.
