HISTORICAL RESOURCES OF THE FORTYMILE RIVER, ALASKA

A THESIS

PARK ADMINISTRATION

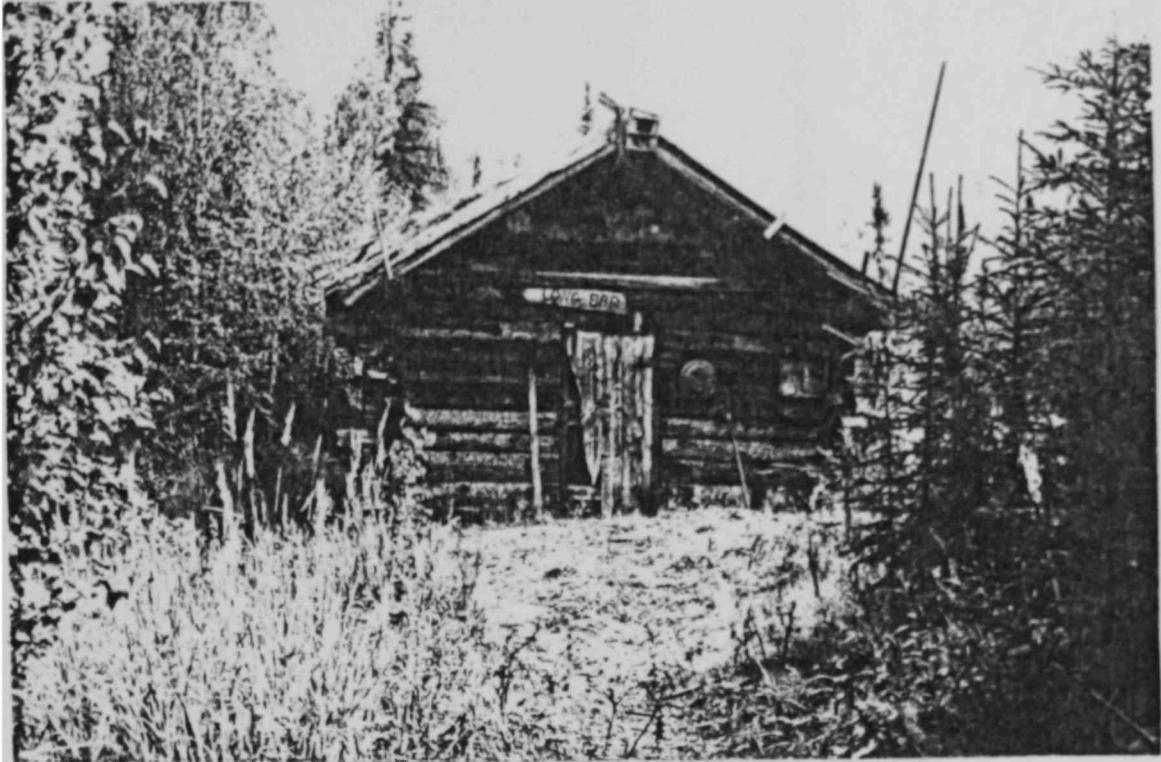
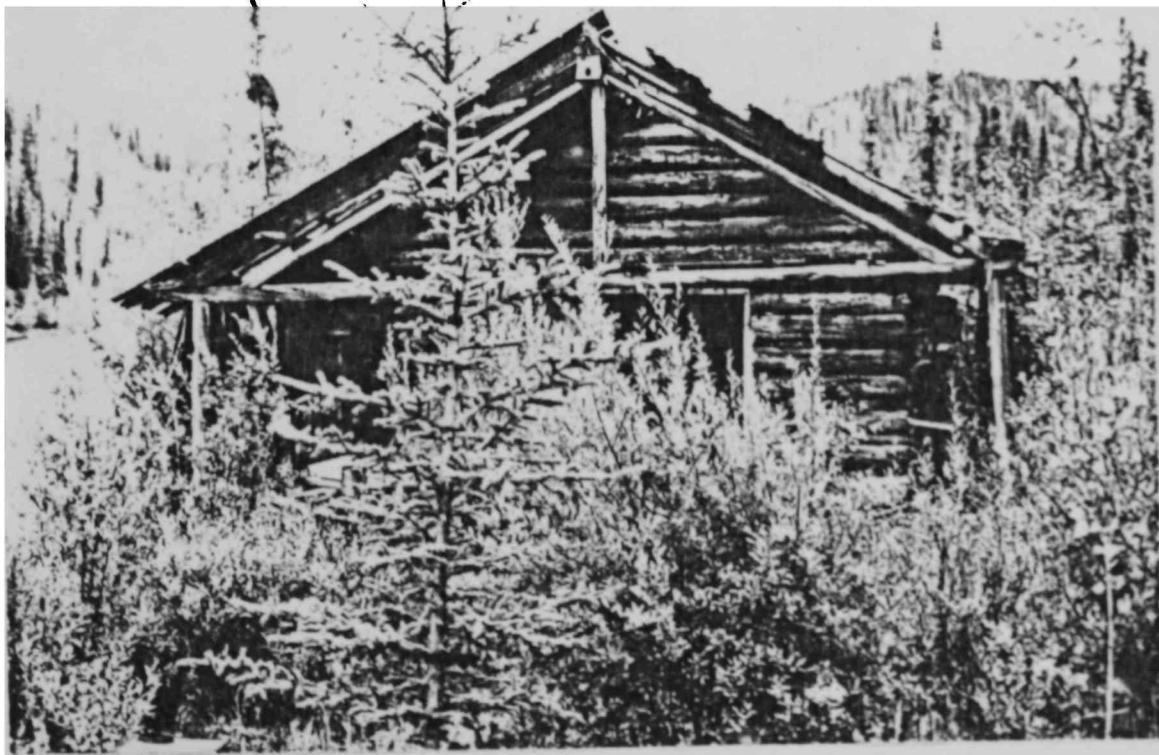
Figure 4. Typical Fortymile River cabins.

Structures are architecturally typical of the gold rush period except for the use of glass in the windows and store-bought door hinges and latches. The majority of the structures have unhewn logs with rather unsystematic notching. Eight cabins have half-hewn logs, and one structure, the Franklin schoolhouse (site 6), was built of sawn logs. Gabled roofs made of poles covered with sod characterize most structures. Two cabins were found with flat roofs. The photographs in Figure 4 depict typical cabins.

Structural improvements should conform in character if not in actual construction techniques to buildings of the gold rush and mining era. Replacement materials should resemble the original as closely as possible. It is recommended that the cabin recently constructed in the study area (site 2) be dismantled because it is poorly constructed and represents an intrusion into public lands. The salvaged materials should be used to repair other cabins.

While extensive restoration projects require detailed architectural studies, basic stabilization of worthy structures could precede such studies under the direction of a restoration architect. Maintaining roofs of cabins to be considered for renovation could retard deterioration and reduce the extent of repairs required at a later date.

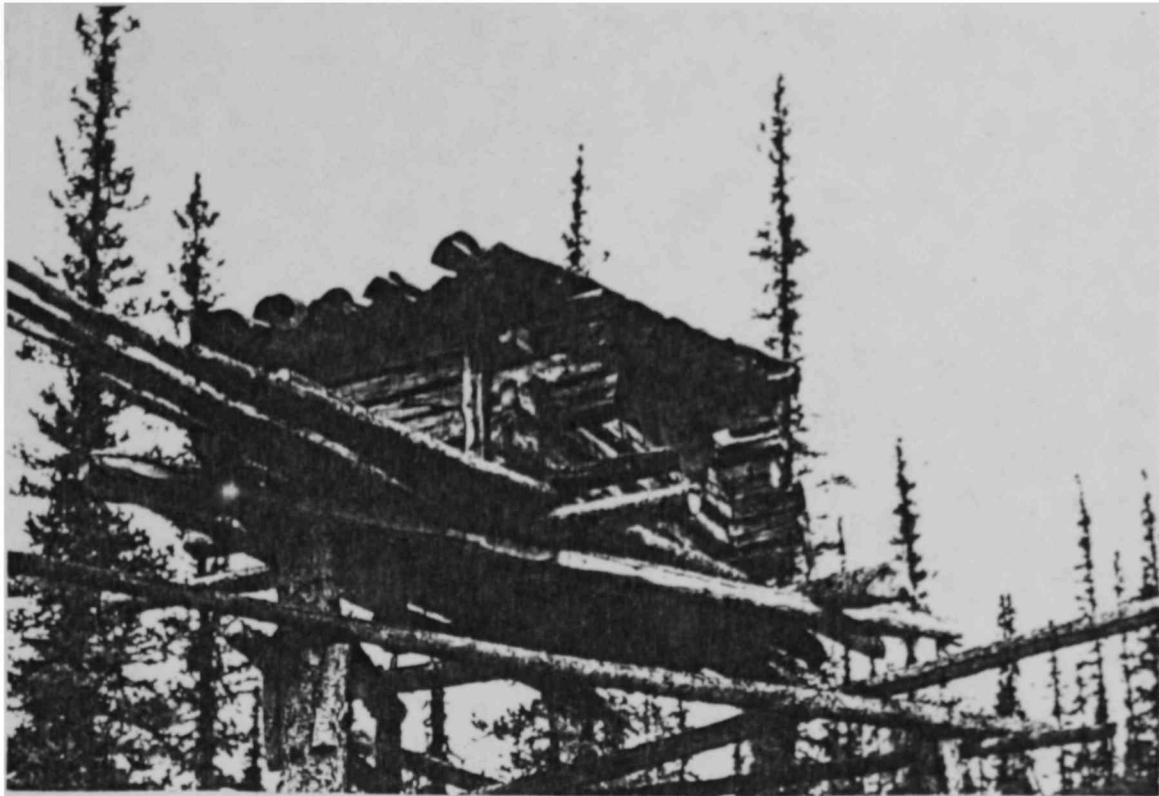
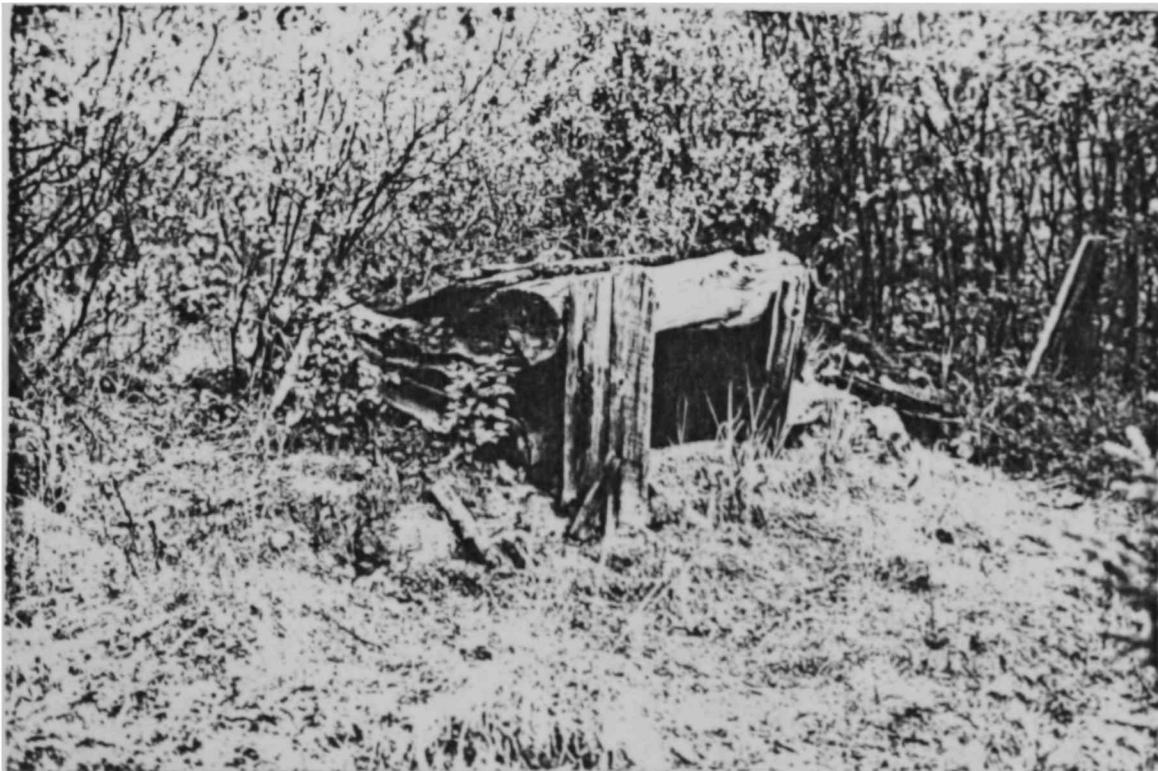
Figure 5. "A" is an elevated food cache. "B" is a log dog house.

Most cabins also had an elevated food cache nearby, although most of these have collapsed. Square dog houses built of logs are not an uncommon site feature. A typical cache and dog house appear in Figure 5.

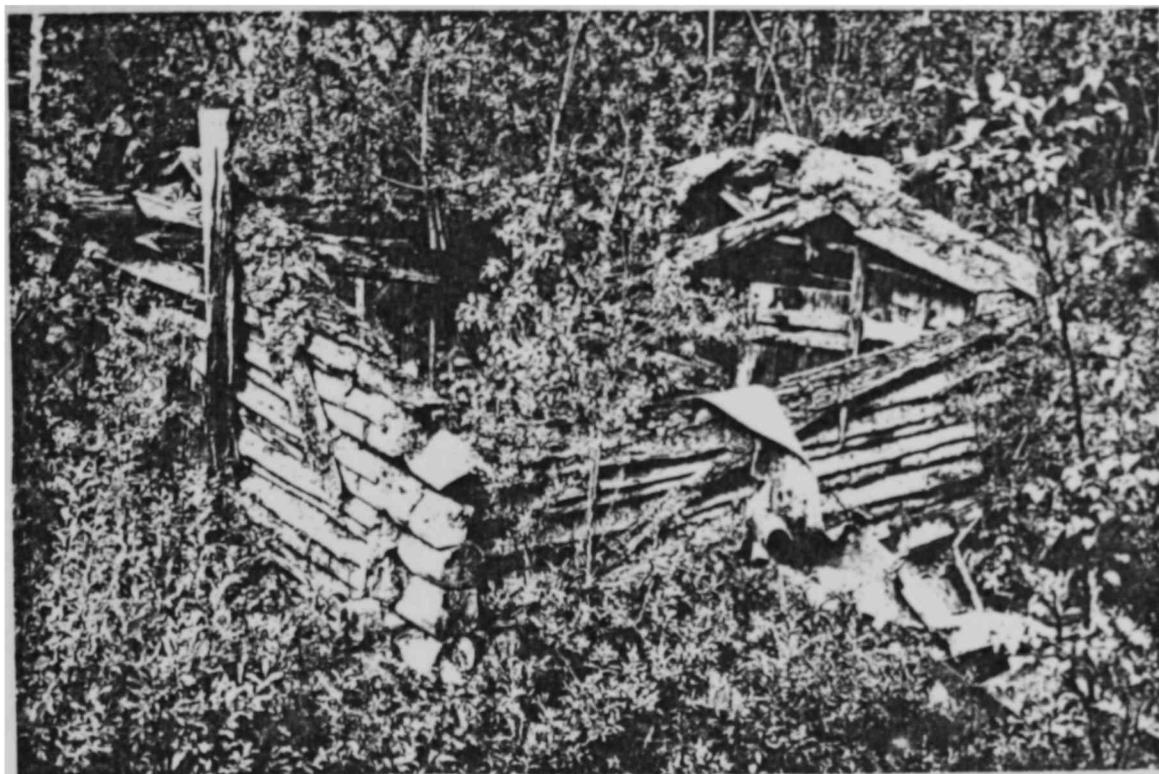
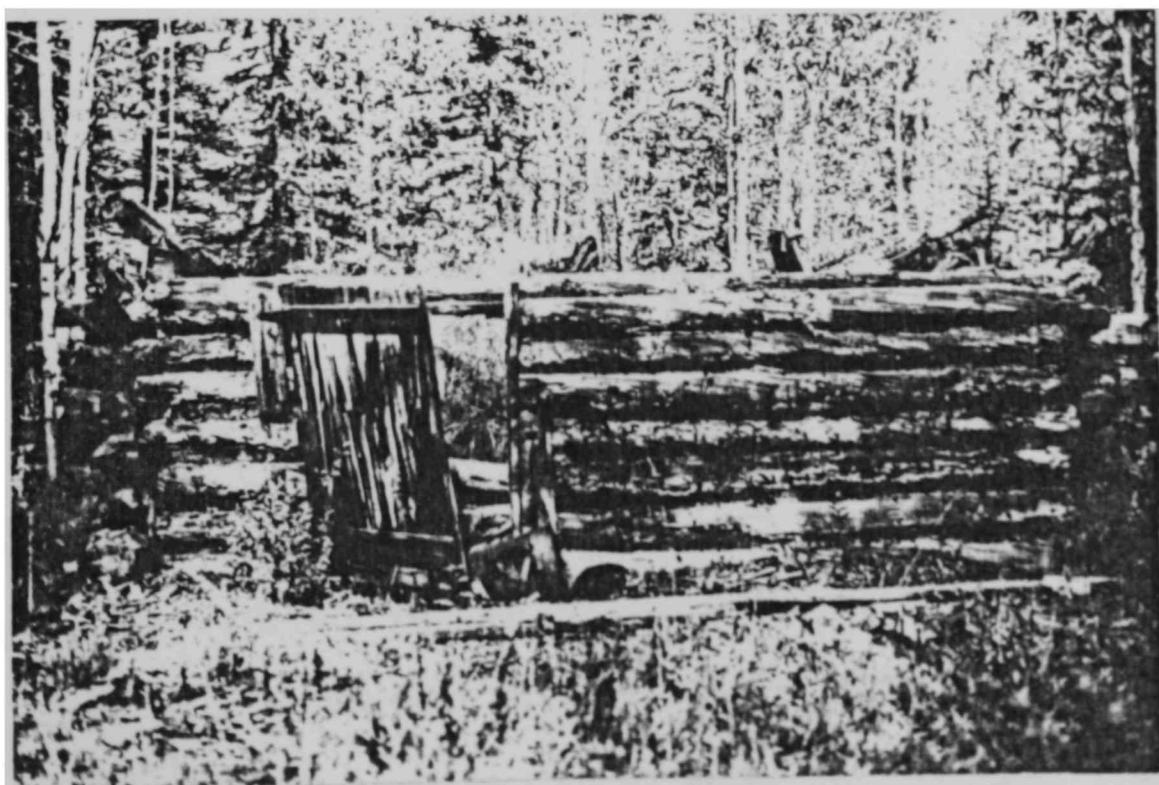
Figure 6. Ruins of Fortymile River cabins.

Twenty-two sites are structural ruins with collapsed or non-existent roofs. Ruins range from those one or two logs high to more recent fatalities with walls basically intact although badly deteriorated. Figure 6 shows examples of ruins in the area. None

of the ruins possess historical significance which warrants restoration with the exception of the Franklin Roadhouse (site 10) which is shown in Figure 7.

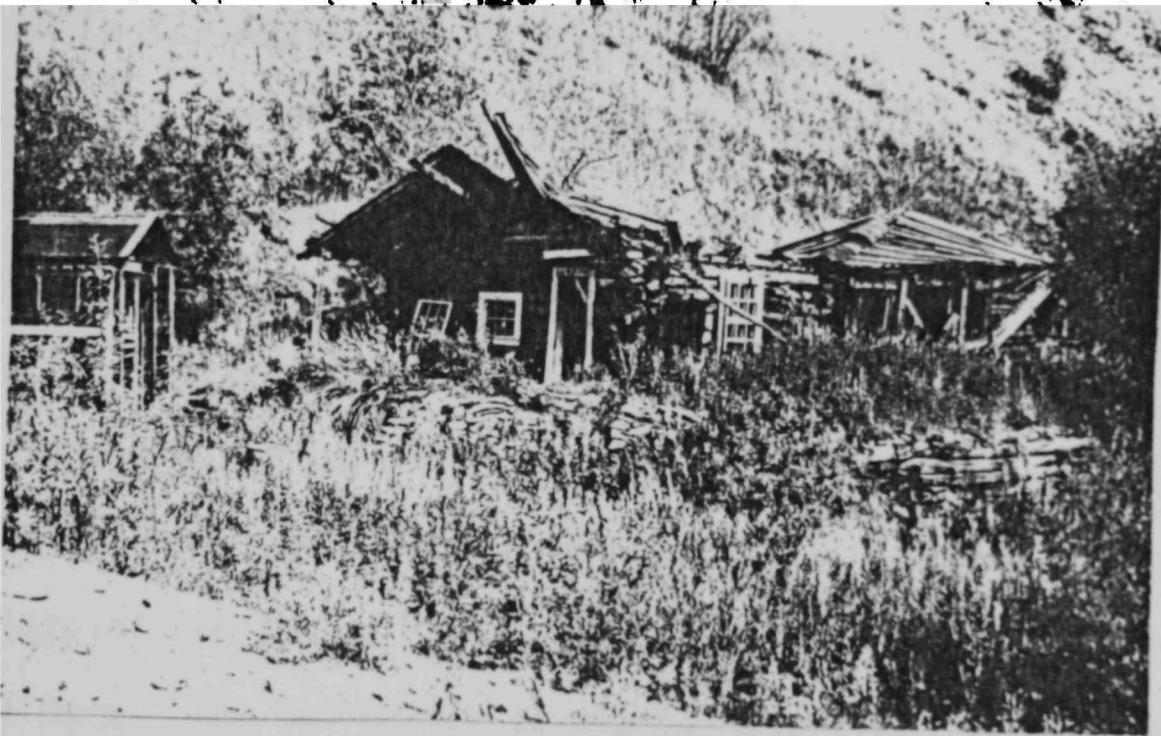
Figure 7. Franklin Roadhouse.

A more likely basis for inclusion in the National Register, however, would be a historical district nomination for Franklin Community. The roadhouse was the focal point and the most significant building in the community which had a post office from 1902 to 1945 and a school from 1927 to 1933. A blacksmith shop and drift mining operation were located immediately across the river, and boiler ,

cables, and other remnants of the operation are scattered about. Allowances for restoration of the roadhouse would have to be made if the structure were to become an interpretive center or to serve some other purpose and still qualify for inclusion in the National Register. Whether or not the structure attains National Register status, the roadhouse should be recognized as the most historically significant structure in the study area.

It is important to note that the roadhouse is located on a valid mineral claim although no significant mining activity has occurred there for many years. Proper negotiations with the claim holder must be conducted before any of the recommended developments can proceed.

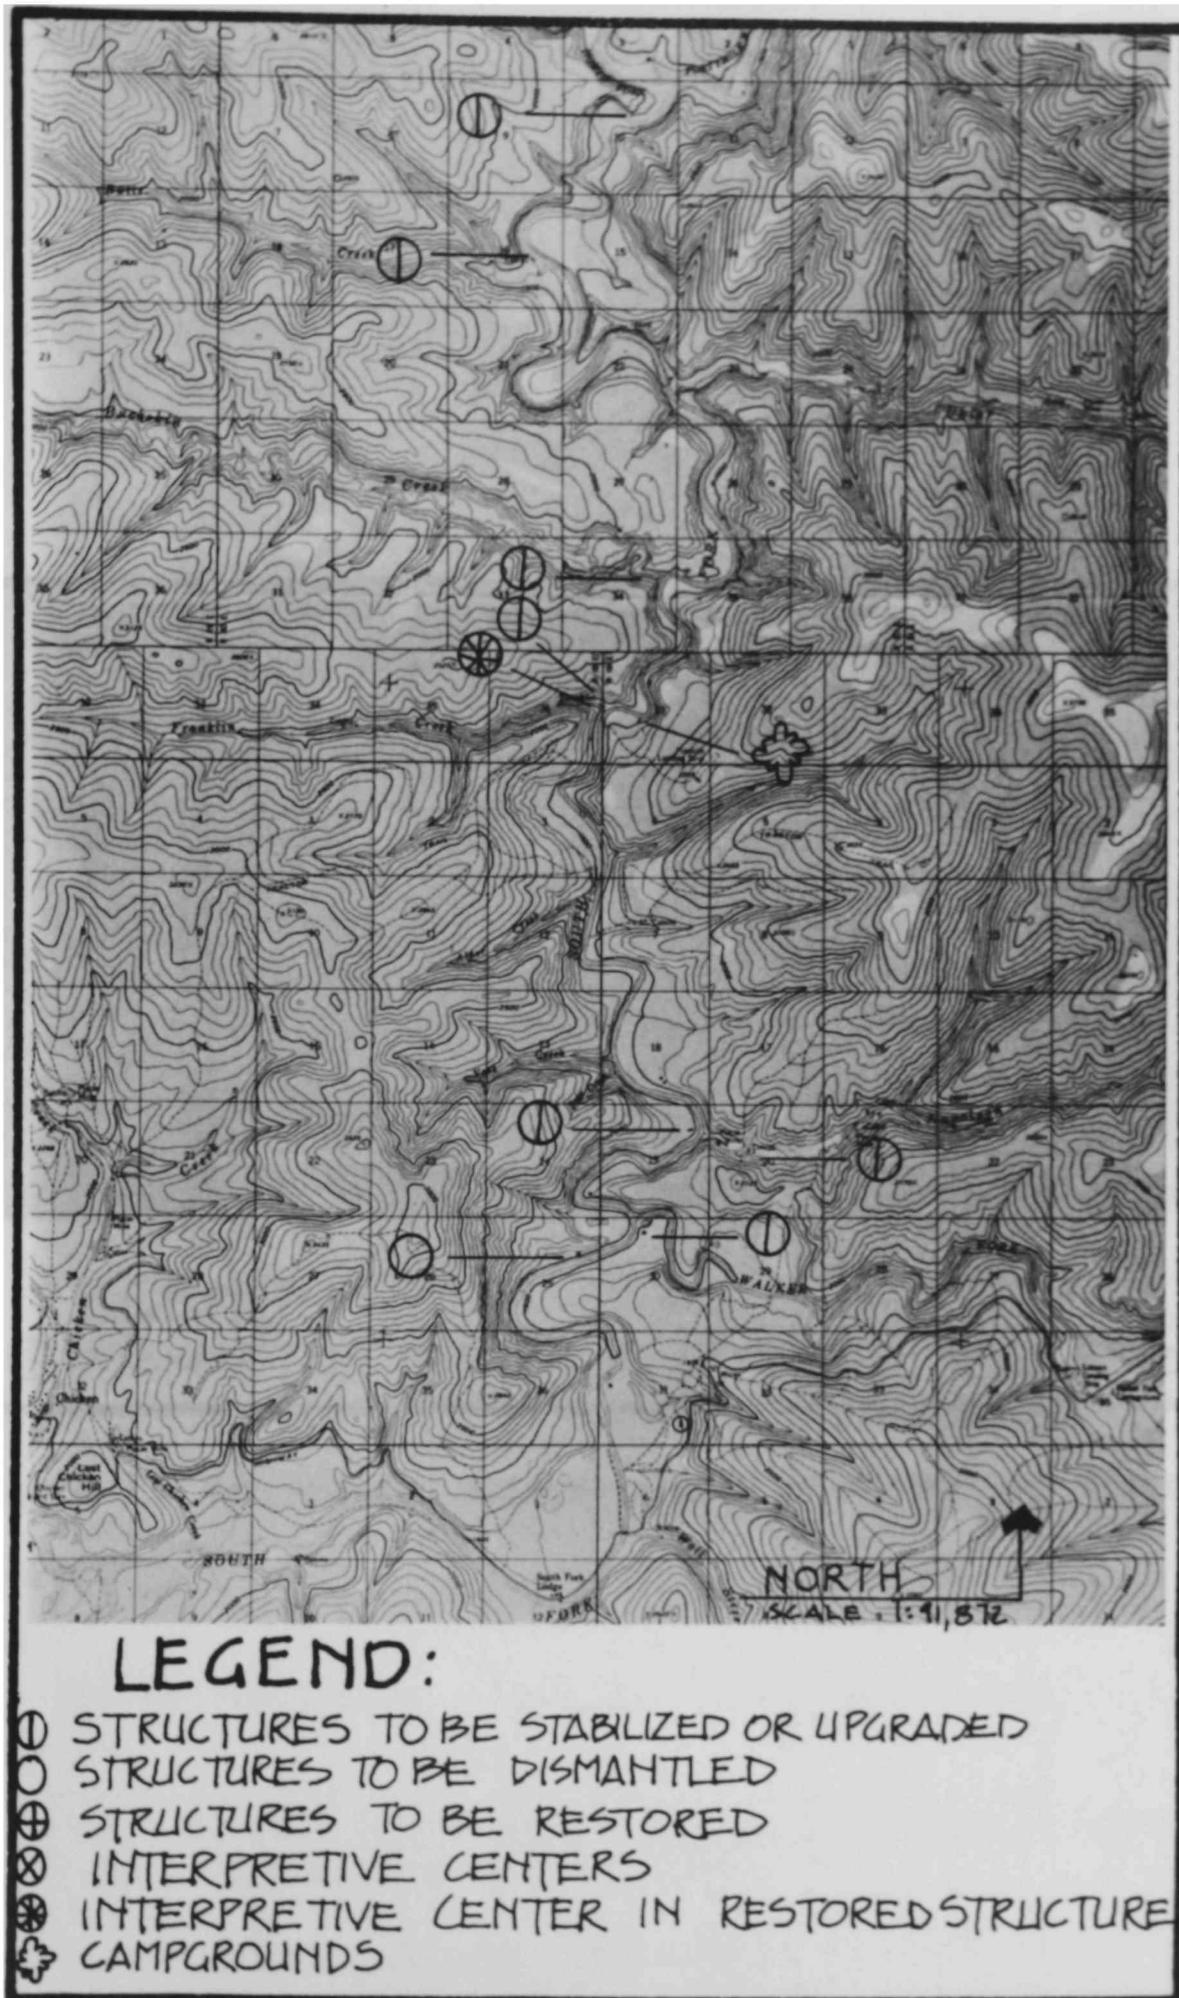
Figure 8. Recommended action in area of historical sites 1-20.

Locations of recommended management practices summarized herein are shown in Figures 8 and 9 which correspond to the site location maps in Appendix B.

Focal points for interpretive developments should be Franklin (sites 9-12) and Long Bar (site 22). Concentration of readily accessible historical resources at Franklin attracts recreationists in the study area, and an interpretive center should provide information not only about Franklin but other sites as well. Location of interpretive materials at Long Bar is recommended because of site location and historical significance.

Two campgrounds should be established to accommodate river recreationists in the area. Campgrounds should be located at areas already frequented by campers in order to confine impacts of visitors to given areas.
