Lessons Learned for the International Space Station Potable Water Dispenser

Brandon W. Maryatt¹

NASA Johnson Space Center, Houston, TX, 77058

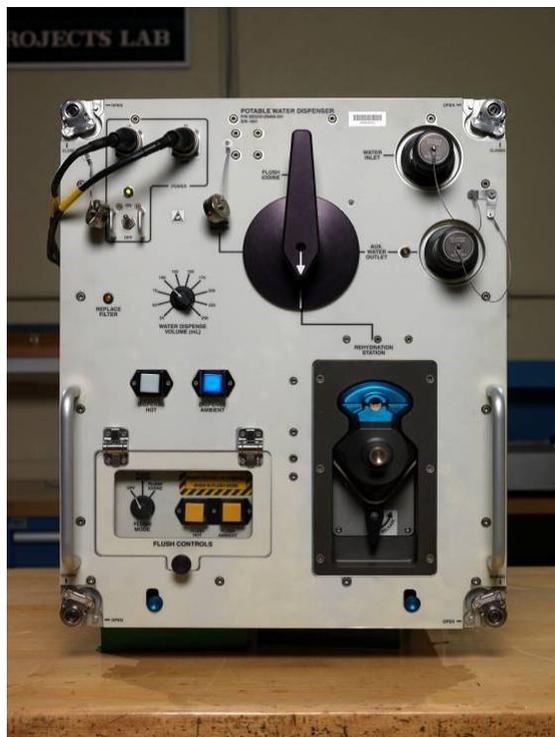
Figure 1. First PWD flight unit.

Two PWD flight units currently exist. The first unit was developed, built, and certified between 2007 and 2008 and was launched on STS-126 in November 2008 (Figure 1).¹ This unit commenced on-orbit operations in early 2009 and continues operations to this day. The PWD is designed for 10 years of operation; however, the first PWD unit is currently designated to run to failure. A second PWD unit was built to support operations of the ISS beyond the original 2018 timeframe. This unit was built between 2011 and 2014 and includes design upgrades based on lessons learned from the first PWD unit. The second PWD unit is currently designated to launch on need for when the first PWD unit suffers an unrecoverable failure. During storage on the ground, the second PWD unit undergoes periodic maintenance to keep microbial growth in check and ensure hardware readiness for when it must launch to the ISS to replace the first PWD unit.

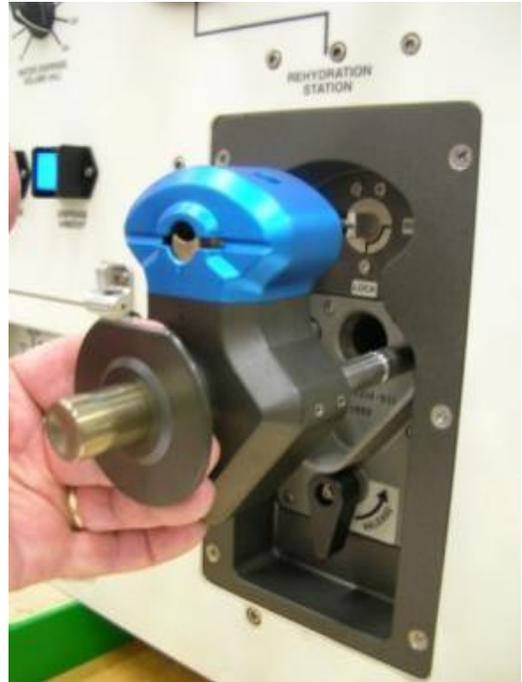
Figure 3. Rehydration Station with Beverage Adapter Assembly.

The primary crew interface on the PWD is an area on the front panel called the Rehydration Station. This area contains the dispensing needle for the crew to interface the food and drink packages for rehydration. The original design for this section included a moveable interface called the Beverage Adapter Assembly (BAA) (Figure 3). The crew member would pull out the BAA, insert the septum/tip of the food or drink package into the BAA, which would hold the package in place, then push the BAA back into place, which would pierce the food or drink package's septum onto the PWD dispensing needle. The BAA assisted in this action by lining up the septum with the needle and ensuring the food or drink package was seated an appropriate distance onto the needle; too close and the package adapter would cover the needle hole and prevent water from entering the package, too far and the water would spray outside the package. The Rehydration Station also included a Package-in-Place (PiP) switch that detected when the BAA was fully inserted into the PWD and onto the needle. If the BAA was pulled away from the PWD and needle prematurely, the PiP switch would detect this and stop the dispense early to prevent dispensing water into the open cabin.

This concept proved to be more problematic in practice than in theory.² The PiP switch function was a beneficial control without crew action but, in practice, it was more susceptible to damage and false signals that the food or drink package was not in position. Additionally, when water was flowing into a food or drink package, the force would push the BAA slightly away from the PWD – sometimes enough to trip the PiP switch and stop the dispense. The crew member generally had no idea how much fluid had already dispensed into the package and would have to guess at the remaining dispense volume. This

would also lead to many more cycles than expected on the volume select switch and dispense pushbuttons because dispenses would end prematurely and a second was needed to finish the fill. The BAA design also unintentionally had many small crevices and holes, which would trap water that leaked, thereby leading to bacterial growth. These small areas were very difficult to clean. Additionally, the BAA design required periodic maintenance by reapplying lubrication to the mechanism's slide that was removed by inadvertent water leakage. As a result, the ISS Program directed the development of a new, simplified Rehydration Station to replace the existing Rehydration Station with BAA. This updated design would be incorporated into the in-development second PWD unit as well as retrofitted into the on-orbit first PWD unit.

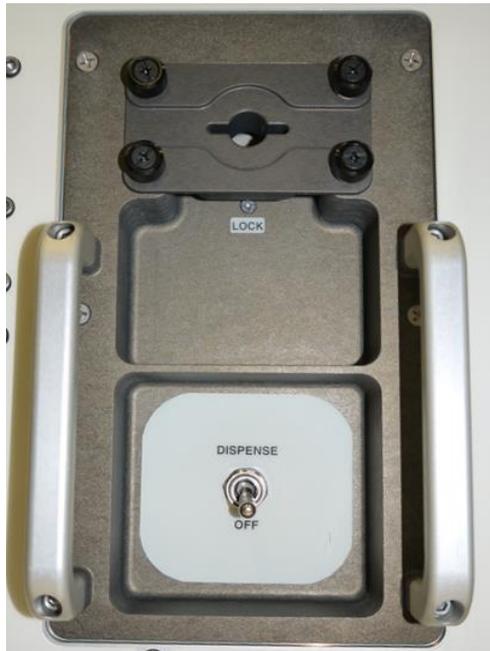
Figure 4. Simplified Rehydration Station.

A few design changes were implemented to simplify the dispense operations of the PWD. The first was the decision that it was acceptable to rely on crew action for ensuring the bag was in place rather than the PiP switch. This allowed the BAA to be removed from the design. A Needle Guard Assembly was added to the Rehydration Station (top portion of Figure 4). The Needle Guard Assembly protects the crew from the functional sharp tip of the needle and potential excessive touch temperatures of the needle following a hot dispense, protects the needle from crew-induced loads, and aligns the food or drink package with the needle and

controls the bag installation depth (mimicking the features of the BAA in this regard). The PiP switch changed from an automatically activated switch to a manually activated toggle located on the Rehydration Station (lower portion of Figure 4). This meant that dispenses would not be stopped prematurely but required the crew member to be more diligent about holding the package onto the needle during the entirety of the dispense. The toggle can still be activated during a dispense to immediately shut it off, should the crew member find that necessary. As a safety feature, the toggle is required to be activated after each dispense before another dispense can be performed. These changes to the PiP switch required no change to the PWD programming. Finally, the geometry of the Rehydration Station was simplified to minimize the small radius and crevices. This simplified geometry is much easier to clean when inadvertent leaks occur from the food and drink package/needle interface.

The new simplified Rehydration Station was flown as a retrofit kit for the first PWD unit on-orbit and installed in 2014. Feedback received since the installation has been positive. Crew members prefer the simplified design for dispenses, and the individual parts – now reduced to just the Needle Guard Assembly – are easier to clean. The Needle Guard Assembly dimensions allow the food or drink package to be mostly held in place due to friction, requiring only a small effort from the crew member. The elimination of premature dispense terminations has greatly reduced the number of cycles on several PWD components which will, in turn, increase their life expectancy. Overall, the update to the Rehydration Station has removed the primary crew complaint of the PWD system.
