# Brine Processor Assembly 2023-24: Operational Successes and Challenges on the International Space Station

The Brine Processor Assembly (BPA), developed by Paragon Space Development Corporation as a one-year technology demonstration, has now been in operation onboard the International Space Station (ISS) for three years. BPA recovers available water from urine-brine produced by the ISS Urine Processor Assembly (UPA) via forced convection of cabin air coupled with a patented membrane distillation process. A dual-layer ionomer and microporous membrane-based bladder retains the liquid brine while water vapor pervaporates into the cabin, for collection as humidity condensate. This paper will discuss updated performance results as well as the practical operational challenges of maintaining hardware on the ISS.

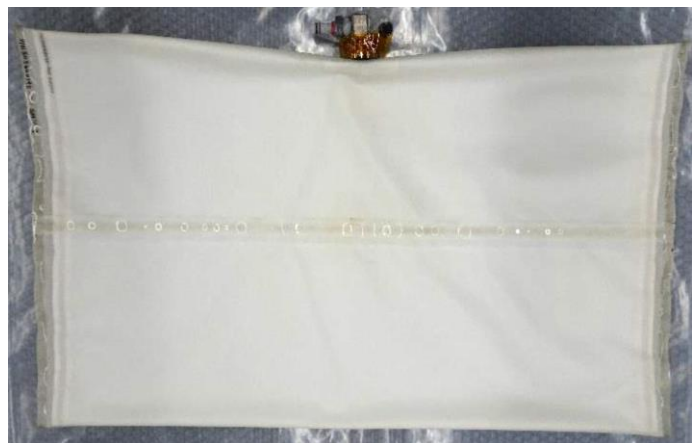
**Figure 1. Brine processor bladder (unused).**

The Brine Processor Assembly utilizes forced convection of spacecraft cabin air coupled with Paragon's patented IWP membrane distillation process to purify and recover >80% of available water from 21.8 liters of brine within a 14-day cycle. The IWP membranes are formed into a disposable bladder (Figure 1) to contain and process this brine. The dual-layer bladder serves two purposes: 1) a method of containment of the high toxicity level (Tox 2) brine and 2) the technology by which water is recovered. The inner bladder retains solids and liquids but allows water vapor and some trace contaminants to pass through its microporous membrane. The outer ionomer bladder is also permeable to water vapor and fewer trace contaminants. Because the membranes are extremely lightweight, the entire IWP membrane structure is disposable with the brine, maintaining brine containment throughout the life of processing and disposal. At 0.5 kg total weight, the consumable bladders are well within the AES exploration program goal of brine processing consumables mass of 25% or less of recovered water mass.

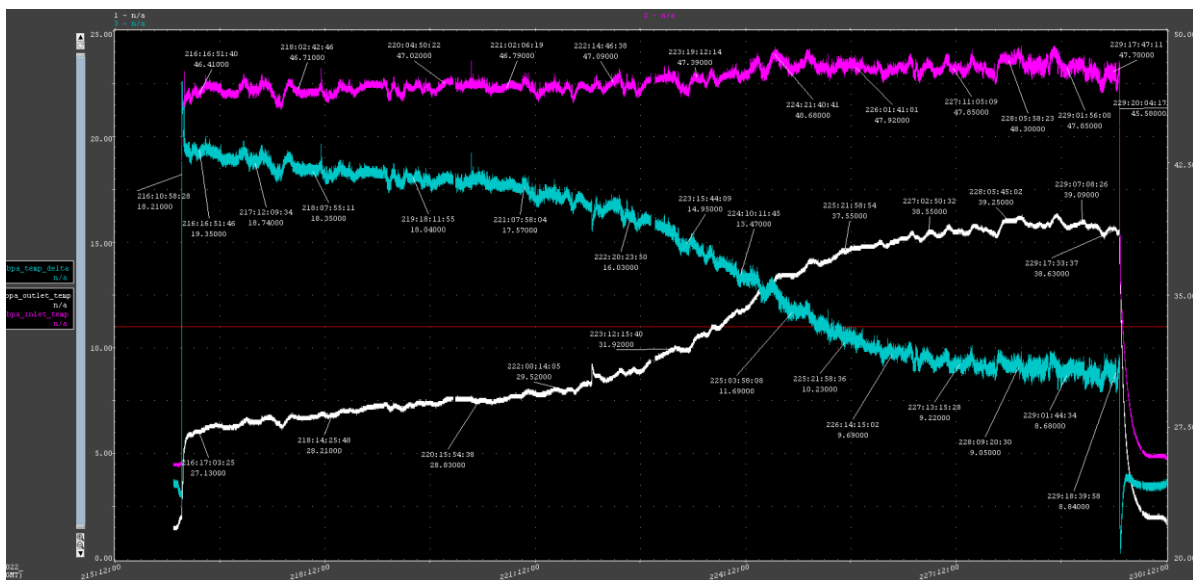
Figure 3. Telemetry for operational dewatering cycle # 14 indicating the beginning and end of the run as a raw data downlink. Pink trace is inlet temperature, white trace is outlet temperature, and blue trace is delta temperature.

Select on-orbit telemetry data for the first dewatering run with a permanent filter can be seen in Figure 3. The temperature profile during a dewatering cycle remains steady for the beginning stages of operations. The inlet and outlet temperatures converge as less water is available to recover, thus decreasing the evaporative cooling due to the water's latent heat of vaporization. Dewatering cycles are concluded once the delta temperature across the inlet and outlet plenums of the BPA reach a certain known value based on the heater setting. The BPA's inline heater consists of three independent heater coils. The Heater receives 28V power and can be set to seven discrete temperatures (based on ambient conditions) by selecting different combinations of heater coils to be powered. Operational cycles run at higher heater settings, for example, will be terminated at a higher delta temperature value (i.e. Inlet – Outlet temperature). The maximum power draw of BPA, which is currently nominal operation, is 195 Watts.

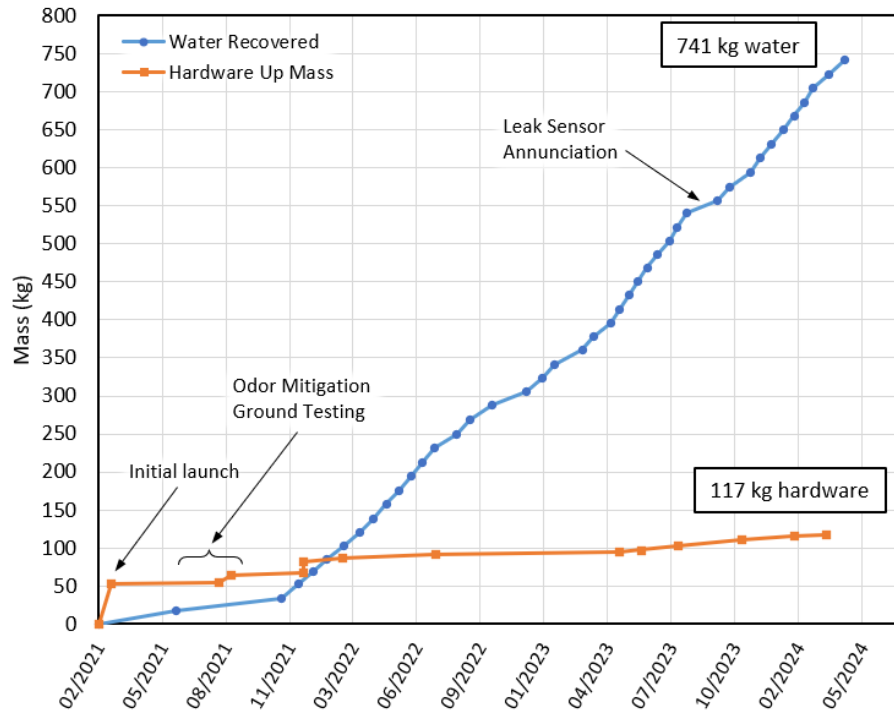
**Figure 4. BPA water recovered vs. hardware up-mass since launch. Includes all spares and consumables launched as of May 2024.**

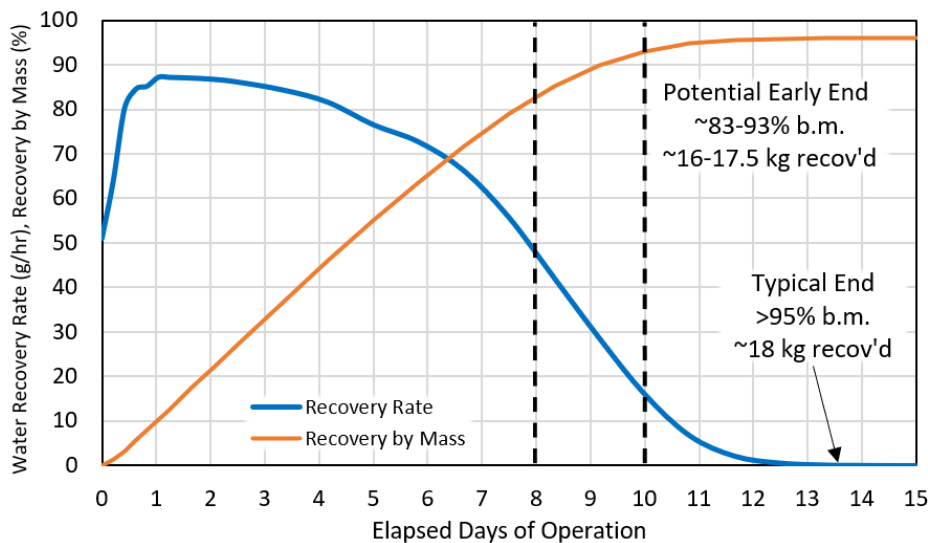
**Figure 5. Dewatering model recovery metrics and illustration of short-cycle benefits.**

the most water is removed from the brine, but recoverable water might be lost if brine needs to be trashed in-between cycles because the BPA is not available. Therefore, a shorter cycle where less water is recovered per brine batch may actually recover more water in the long run. This potential trade is demonstrated with Figure 5, which shows a sample run of the BPA dewatering cycle’s water recovery metrics. Note that the water removal rate declines rapidly after the 8 day mark, and essentially very little to no water is being removed after 12 days for this run. These estimates help assess when to cease an operational run; now that there is a large set of operational data on-orbit, the BPA team can more confidently assess when to end BPA operations. Further optimizing the cadence of BPA operations with UPA operations on ISS will allow for the most efficient water recovery and storage on-orbit.

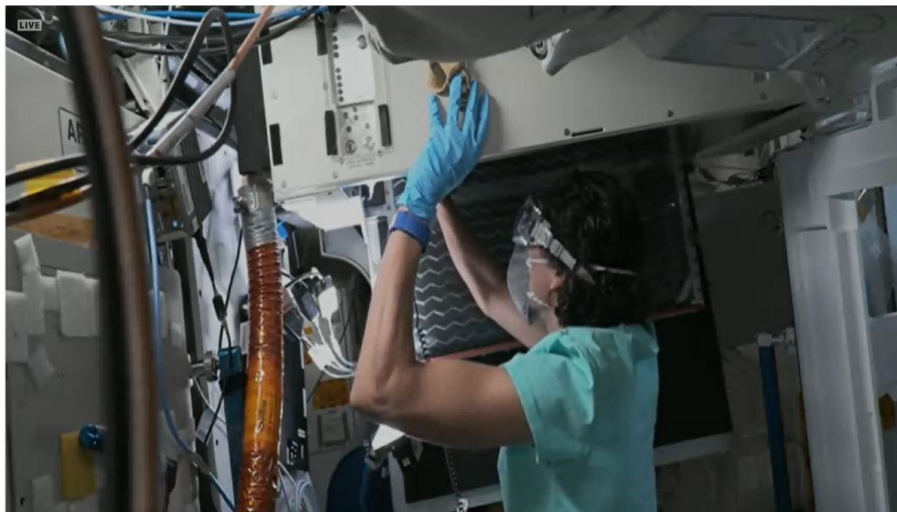
**Figure 7. Image of BPA leak sensor cleaning activities showing ISS crewmember Jasmin Moghbeli working on the BPA. Photo credit: NASA ISS Imagery Online.**

Downlinked video of the cleaning activities on ISS was requested to be able to monitor cleaning progress and give feedback to the crew during cleaning activities. This afforded the Paragon and NASA BPA teams the opportunity to observe and work around the logistical difficulties crew experienced during cleaning procedures. Despite the live camera footage, there was some appreciable delay between communication among the BPA team, NASA Ground Communications, and the transmittance of audible commands to crew. These practical delays in communication necessitate thorough preparedness for off-nominal crew procedures, so multiple if/then contingency plans and instructions were included during the development of the cleaning procedures. A snapshot of American astronaut Jasmin Moghbeli during a cleaning activity is shown in Figure 7.

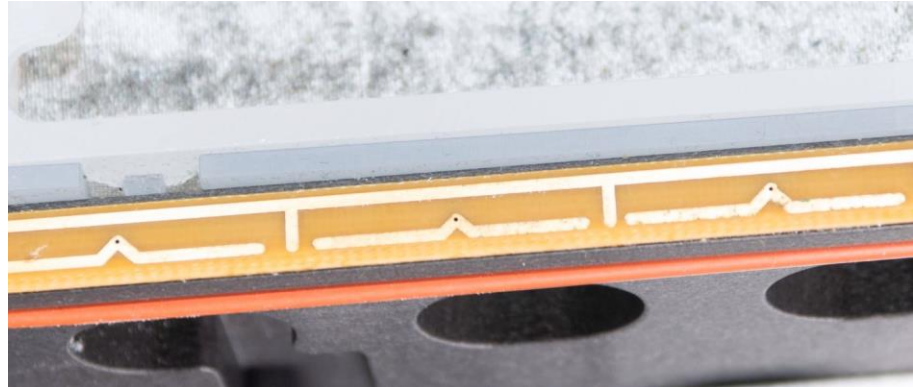
**Figure 8. Image of BPA leak sensor after several rounds of cleaning activities showing significant reduction in corrosion. Photo credit: NASA ISS Imagery Online.**

Ultimately, through multiple cleaning activities with various crew members, the corrosion on the BPA Leak Sensor was significantly reduced, almost eliminated in many areas, as shown in Figure 8. A test to short the sensor by laying a screwdriver across the two leads was successful, immediately setting the alarm and confirming that its basic functionality was still intact. This gave further confidence that the sensor would indeed work in the case of an actual brine leak. Now that the protective gold layer has been compromised, it is inevitable that additional corrosion will continue to develop as the copper surface is exposed to elevated humidity and temperature during regular operations. Maintenance steps have been added after each dewatering cycle, during bladder change outs, to wipe down the sensor in an attempt to remove any additional corrosion that has developed. The crew also takes photos of the Brine Leak Sensor between each cycle to monitor its condition. As of May 2024, eleven additional operational cycles have been completed with the BPA and all its original (non-consumable) piece/parts. The original Detrusor is still installed, the Brine Leak Sensor continues to function and, with routine wipe-downs after every dewatering cycle, BPA has not incurred any additional false Brine Leak Alarms.
