Development and characterization of the Capillary DirectINJECT System

The DirectINJECT Project was initiated to develop a reliable in-line dosing system to deliver a concentrated silver ion biocide solution at ultra-low flow rates into spacecraft potable water. Three dosing systems, employing a miniature peristaltic pump, a multi-piston pump, and differential pressure-driven flow through a capillary tube, were quickly prototyped and tested. Although the peristaltic and multi-piston pump systems met the desired flow rate range, the capillary system showed the most promise and was chosen for further development. In FY23, the Capillary DirectINJECT dosing system underwent extensive testing with a nominal injection rate of 1.0 $\mu\text{l}/\text{min}$ into varying backpressure conditions. A Primary DirectINJECT System with triplicate testbeds was employed for long-term testing, and auxiliary systems including the Secondary DirectINJECT System and Leak Testbed were developed to characterize specific components and investigate various phenomena related to the dosing system. Parameters such as flow rates, reservoir pressures, and temperature were monitored throughout the testing campaign

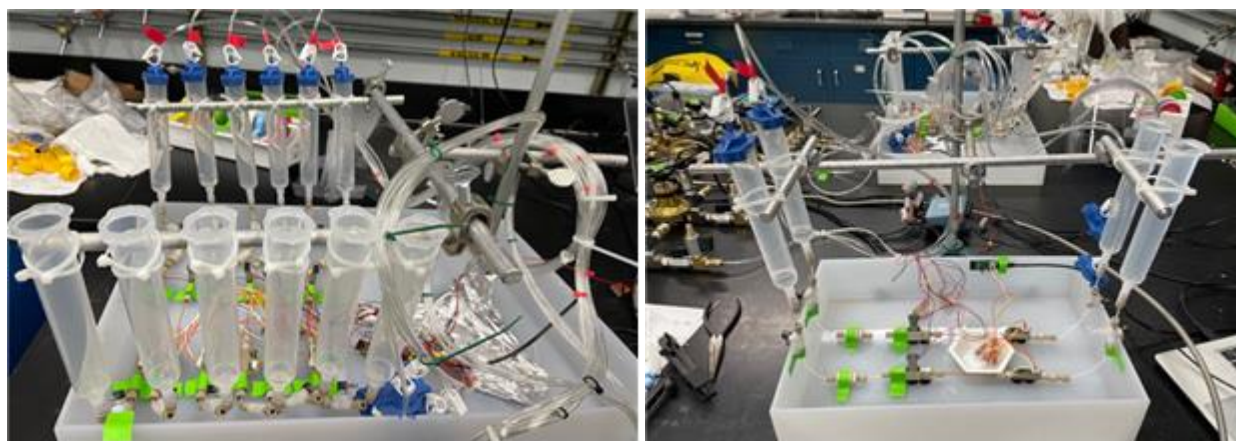
Figure 3. Primary (left) and Auxiliary (right) DirectINJECT Systems.

The 8 supply (6 on the Primary System and 2 on the Auxiliary System) and their respective 8 collecting tanks used as pressurized reservoirs are 50 ml polypropylene pneumatic dispensing syringes (Nordson EFD, part # 7012134) rated at 100 psig, with adapter assemblies (Nordson EFD, part # 7012056) plumbed with a flexible hose to their respective pressure regulators assemblies (Figure 3). Several pistons with different designs and tolerances are available depending on the application. The white, general purpose SmoothFlow, piston (Nordson EFD part # 7012186) made of high-density polyethylene was initially used during the testing and characterization of the Primary and Auxiliary systems. The outlet of the syringes connected via an 0.020" ID ETFE tubing (IDEX, part # 1516L) to a 10 µm pore PEEK frit filter contained in a PEEK holder (IDEX, part #s A-720 and A-355) to protect the capillary tube, followed by a normally closed miniature solenoid valve with connecting flange (Bürkert, part #s 273206 and 694895). The solenoid valve was selected due to its construction with inert and chemically resistant materials (PEEK body and FFKM diaphragm), low internal volume, and long cycle life rating claimed by the manufacturer (3×10^7 cycles under laboratory conditions). A 100 mm long, PEEK jacketed, fused silica micro-capillary tube with an inner diameter of 25 µm (PEEKsil™, IDEX part # 62510) is directly connected to the solenoid valve. The fused silica core provides a

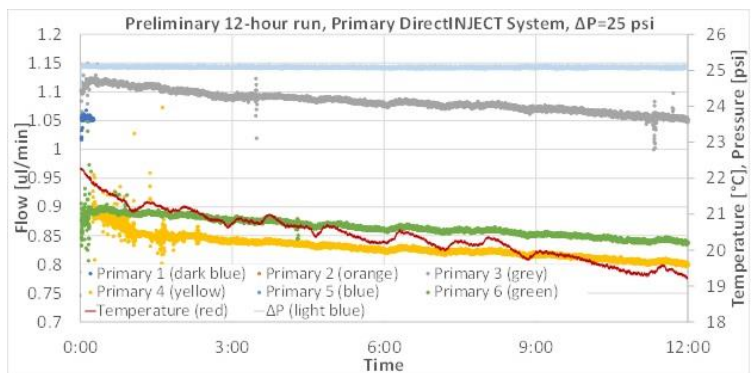
Figure 4. Flow rates and ambient temperature of preliminary 12-hour test. Pressure set at 25 psig, and all collecting tanks open to the atmosphere. Time is in hh:mm.

A first preliminary 12-hour test was conducted with all the Primary and Auxiliary supply tanks connected to a single pressure regulator, set at 25 psig. All the Primary and Auxiliary collecting tanks were open to ambient atmosphere (0 psig) but covered with parafilm. The flow rates were recorded from both systems using 2 separate USB inputs on the same laptop after several attempts to debug the PowerShell program. The data from the pressure transducers DAQ and the temperature DAQ was recorded on DAQami using the 2 remaining laptop USB inputs, using sample rates of 2 Hz. The average theoretical flow expected for these experimental conditions was 0.94 $\mu\text{l}/\text{min}$. 3 out of the 6 Primary testbeds did not have any flow at all during this run. The trendlines of the flows are shifted, resulting in different average flow rates over the 12 hours, as seen in Figure 4. However, the drop in flow over time corresponds to temperature drop overnight, as expected, and as shown in detail in Figure 5. The root cause of the different flows was believed to be either a constricted capillary tube due to either manufacturing tolerances or the over-torquing of its fittings, or to an obstructed/broken glass capillary in the flow meter. The root cause of the complete absence of flow was first believed to be due to failed solenoid valves. Thus, the next steps were to characterize the single system components since they were never tested

The Auxiliary system recorded random, off-range “3.072” $\mu\text{l}/\text{min}$ values throughout the run. The root cause of this glitch was believed to be either the sampling frequency set in the PowerShell program or a more likely bad electrical connection. The wiring was inspected and re-soldered, and the Auxiliary System was successively tested using different sampling frequencies.

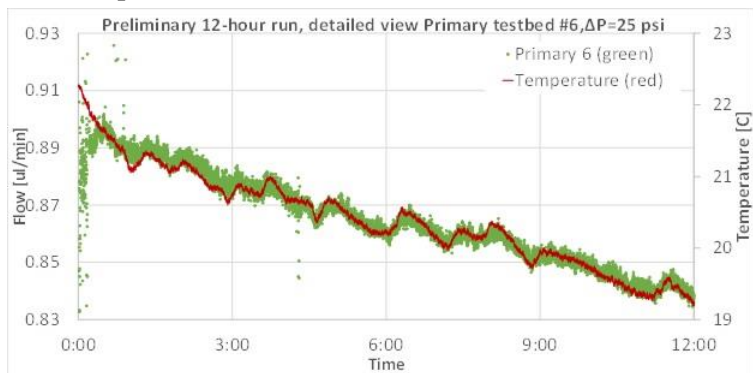
Figure 5. Detailed view from graph in Figure 4. Flow rate of Primary testbed #6 in function of temperature. Time is in hh:mm.

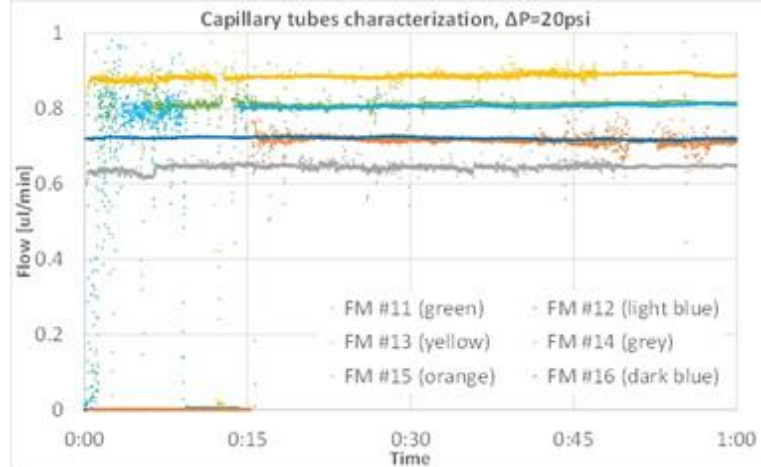
Figure 7. Capillary tubes and flow meters characterization test. Supply tank pressurized at 20 psig collecting tank open to the atmosphere. Time is in hh:mm.

The solenoid valves characterization testing demonstrated that all the solenoid valves were working properly and thus they were not responsible for the complete absence of flow during the preliminary run, as previously hypothesized. Thus, the next components to be isolated and characterized were the capillary tubes and the flow meters. A single testbed on the Primary system was used to test all the capillary tubes and flow meters at $\Delta P = 20$ psi. The supply tank was filled with 10 ml of DI water and its pressure was set at 20 psig, while the collecting tank was open to ambient atmosphere, (0 psig). Every capillary tube was tested for 1 hour using the same flow meter, and then every flow meter was tested for 1 hour using the same capillary tube.

Two of the 3 capillary tubes that did not have any flow at all during the preliminary run worked nominally after they were re-plumbed to the testbed used in this testing campaign. Only 1 of them continued to not provide any flow. This capillary was replaced with a brand new one and the flow through the testbed was restored, indicating that it was most likely damaged during the system integration process. The results of this testing campaign indicate that the flow is capillary-tube-dependent since the flows for each tube overlap regardless of the flow meter used (see graph in Figure 7). Thus, the capillary tubes are the components ultimately responsible for the proper function and for the different flow rates observed in the different testbeds, since the laminar flow of an incompressible fluid through a cylindrical pipe is directly proportional to the fourth power of the radius of the pipe itself (R^4), as described by the Hagen-Poiseuille equation in Eq. (1). This excludes de-facto the flow meters and all the other components of the DirectINJECT system, although the solenoid valves might have a minor effect on the flow rate due to the heat transfer to the flowing solution. The variance between the different capillary tubes is due to manufacturing: the manufacturer lists an ID

tolerance of $\pm 1 \mu\text{m}$ ($\pm 4\%$). Based on the results of this characterization, the tubes used in the system have a calculated ID between approximately $23.75 \mu\text{m}$ and $26 \mu\text{m}$, thus a tolerance of -5% to $+4\%$ with respect to the nominal value.

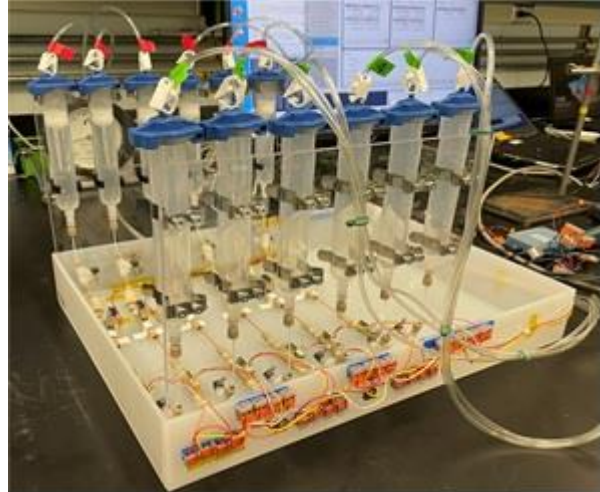
Figure 9. Upgraded Primary DirectINJECT System.

During the third and fourth week of testing, three profiles showed a sudden decrease or increase in flow in two separate occasions. This happened in coincidence with the manual replenishment of the supply tanks with DI water and is due to the unintentional but unavoidable movement of the system which caused the capillary tubes to get bent or unbent from their previous equilibrium status. Thus, the Primary DirectINJECT System was re-designed to secure

all the components of the testbeds to a structural support frame and thus reduce their susceptibility to external mechanical forces. Moreover, the support clamping was modified to avert the deformation of the inner diameter of the tanks, which prevented some pistons from flowing down the barrels once they reached the level of the clamps. This modified design (see Figure 9) successfully prevented any accidental failures of the capillary tubes and electrical parts during tank-refill operations performed in the following 4 weeks of testing.

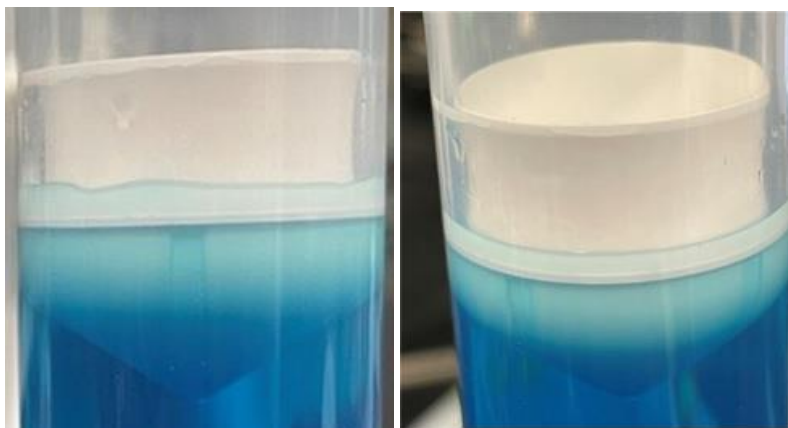
Figure 11a (left). Leakage in the piston channel after its insertion, tank not pressurized.

Figure 11b (right). Leakage in the channel after insertion and pressurization to 30 psig, time T = 0.

Both Auxiliary supply tanks were filled with 30 ml of dyed DI water so the tanks would be filled to about half height, corresponding to the maximum expected deformation of the shell, when pressurized. Both tanks were connected to the same pressure regulator, set at 30 psig, and the pressure was maintained constant for the entire duration of the experiment. The supply tanks were also maintained in a vertical position. The white "SmoothFlow" pistons were inserted in both tanks manually. During the insertion process, one of them required a much higher manual compression force, indicating likely different dimensional tolerances between the tanks and/or the pistons. Some water

got initially entrapped between the upper and lower wipers of the pistons (the groove) during the insertion process (Figure 11a). After pressuring the system, the entrapped water got evenly distributed in the groove along the contact perimeter between the lower wiper itself and the surface of the tank and is due to the non-airtightness across the upper wiper of the piston rather than to pure surface tension (Figure 11b). The system was inspected every 24 hours to identify new leaks or to measure the leak rates. After the first 24 hours, the water level within the groove decreased and after 48 hours it completely disappeared, indicating that it fully evaporated (Figure 12a). No leakages were observed over the following 48-hour period.

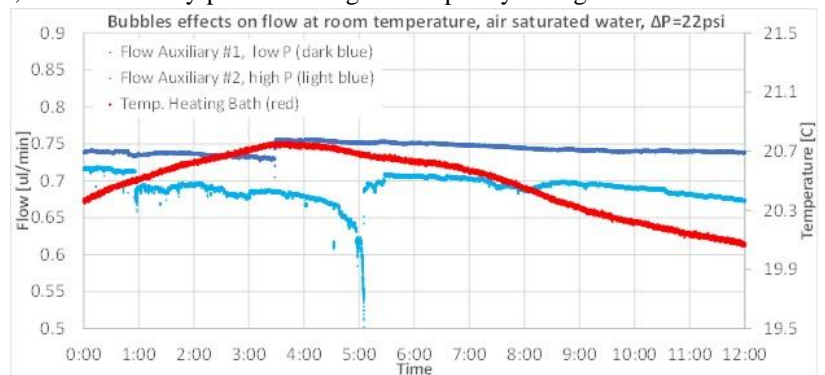
Figure 15. Bubbles effect on flow rate of DI water supersaturated with air at room temperature with capillary tubes in a vertical configuration, $\Delta P = 22$ psi. Time is in hh:mm.

No anomalies (bubble effects) were observed at 20°C in the horizontal experimental configuration. In the experiment in the vertical configuration (Figure 15), a few anomalies were observed. First, in the high P channel (Figure 15, light blue), there was a decrease in flow starting at 1hr. This decrease continued to increase (albeit very jaggedly) until at about 4.5hr it began to more rapidly decrease. This decrease continued until just after hour 5 when it suddenly increased. This behavior is not attributed to a gas bubble, but rather to some ultra small particulate which entered, bounced around, and then finally exited the capillary tube. If we now focus on the low P channel (Figure 15, dark blue), a slow and steady decrease in flow is observed. This could possibly be a bubble effect. If a bubble nucleated and then grew within the capillary, there would be a slow constriction of the flow channel giving a very slow decrease in flow rate as is observed. This bubble, could be slowly pushed through the capillary as it grew until it reaches the end of the capillary at which point the flow through the capillary would be rapidly restored, as is observed at about 3.5 hrs into the experiment. After hour 3.5, a slow decrease is again observed which could be the beginning of another gas bubble. This result implies that if gas bubble formation does occur, that its effect is less than 1% of the total flow rate and so would have no effect on the reliability of the process.

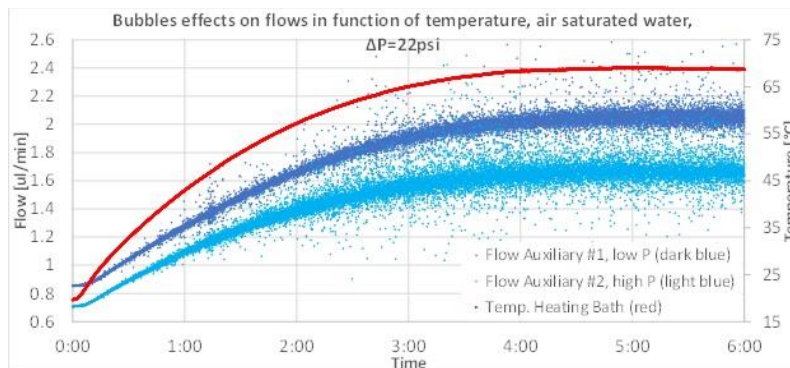
Figure 16. Flow rates of DI water in function of its temperature with capillary tubes in a vertical configuration, $\Delta P = 22$ psi. Time is in hh:mm.

At $\sim 70^{\circ}\text{C}$, scatter was observed in the recorded flow data both for the horizontal and the vertical configurations (Figure 16). If this scatter is due to the presence of micro/nano bubbles, this indicates that they do not affect the overall performances of the system since the average flow was in line with the expected theoretical value. A more probable explanation of this scattered data is that the type of flow meter used in the DirectINJECT System is a calorimetric flow meter calibrated for H_2O at 23°C . By nature, its accuracy is

affected by variations in temperature, heat capacity, and viscosity of the fluid. The flow meter is subject to an error of 0.09% of the measured value / $^{\circ}\text{C}$ (according to the manufacturer). The flow meter measures the asymmetrical temperature of a fluid flow between two temperature sensors, respectively mounted upstream and downstream of a heating element in the direction of flow. The higher the temperature of the flowing media, the smaller is the difference in temperature between the two sensors, and thus the higher the error. Moreover, at $\sim 70^{\circ}\text{C}$, the temperature of the water flowing across the meter exceeded the operational temperature range recommended by the manufacturer, which is between 10°C and 50°C , with maximum short-term temperature peaks of 60°C .
