**International Space Station (ISS) Environmental Control and Life Support (ECLS)
System Overview of Events: 2017-2018**

Gregory J. Gentry¹
The Boeing Company, Houston, Texas

Steven F. Balistreri Jr.²
The Boeing Company, Houston, Texas

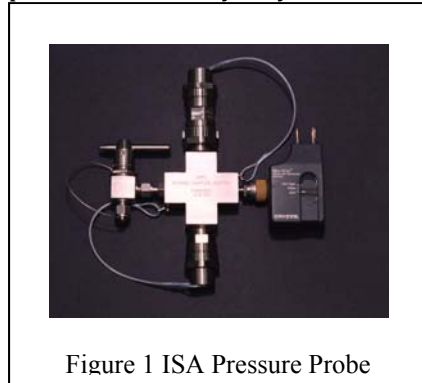
Figure 1 ISA Pressure Probe

The ISA pressure probe uses a Crystal Engineering Multi-Cal pressure module. MultiCal modules don't display pressure, since they only have an electrical output. Instead, the modules convert pressure to millivolts.

Modules are used with devices capable of measuring DC millivolts, such as a digital multimeters or oscilloscopes. MultiCals are calibrated to convert pressure units (for this model, millimeters of mercury or PSIA) to 1 millivolt per pressure unit.

Because the mmHg/PSIA model measures absolute pressure, output is always positive.

The ISA is used to monitor pressure of an isolated vestibule during depressurization prior to unberth of an attached visiting vehicle.

During OA-8 undock on December 5, 2017 the ISA was noted to have erratic readings that were impeding the ability to adequately monitor the depress activity. An astute flight control operator noticed concurrent use of the Commercial-Off-The-Shelf (COTS) Inventory Management System (IMS) tool, known as the RFID-Enabled Autonomous Logistics Management (REALM), may be interfering with the ISA electronics. Some quick troubleshooting (on board crew switching REALM antennas on and off while monitoring ISA pressure reading) correlated the ISA noisy behavior to times when the REALM antennas were on! Figure 1 depicts the ISS MPEV ISA Pressure Probe. Figure 2 shows two of the NASA COTS REALM IMS antennas in the U.S. Lab module. Electromagnetic interference (EMI) issues have always been a concern with COTS hardware. Forward work is to insure the REALM system is turned off prior to use of the ISA for vestibule depresses.

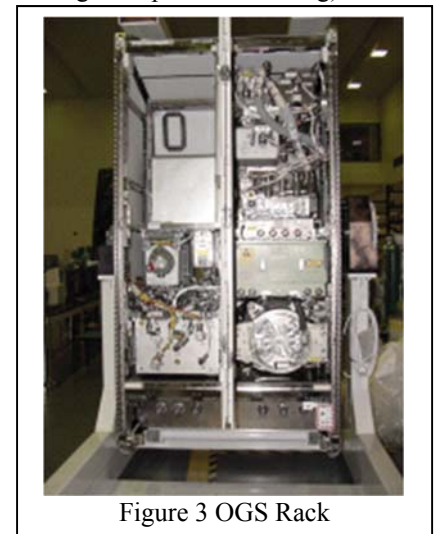
Figure 3 OGS Rack

The OGS rack was launched on STS-121/ULF1.1 in July 2006 and initially installed in the U.S. Lab module for operation. After Node 3 arrived on STS-130/20A in 2010, the OGS rack (along with WRS 1 & 2 racks) was relocated to Node 3. The OGA has accumulated 62,134 hours of operational run time through January 30, 2018 with an *average* production rate of 2.41 kg /day (5.3 lbs./day) oxygen providing a total of 6235 kg (13,716 lbs.) of O₂ and 779 kg (1714 lbs.) of H₂. Figure 3 depicts the OGS rack pre-launch.

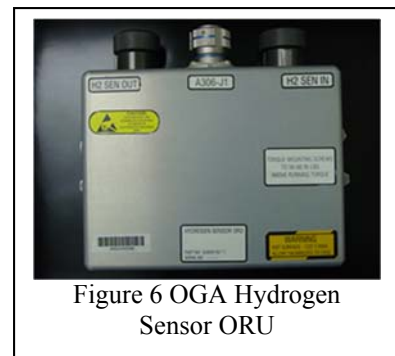
H₂ Sensor ORUs have three sensor dies to redundantly monitor hydrogen in the oxygen outlet stream. ORU S/N 1005 was put in service (second time around) and shortly thereafter sensor die #1 spiked briefly then came back to normal, while the other two diodes did not register any change. A day later sensor #1 spiked off scale high and railed and has been there ever since. The sensor has been inhibited and the ORU is running on the two remaining sensors. The ORU has a 201 day service life and is scheduled for removal on June 18, 2018. While a fault tree has been developed and electrical circuits and power supplies common to all three sensor dies have been exonerated, determination of root cause will have to wait for the ORU to be returned to the original equipment manufacturer (OEM).

Figure 6 depicts the OGA H₂ Sensor ORU.

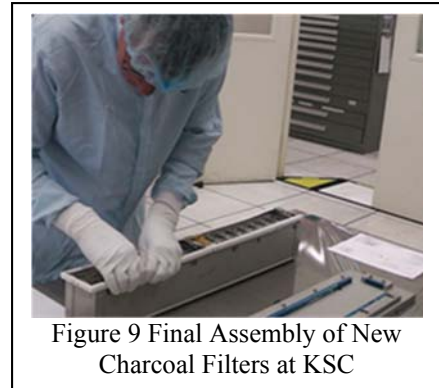
Figure 9 Final Assembly of New Charcoal Filters at KSC

While the source of the PDMS contaminants on ISS CCAA CHXs cannot be eliminated, a method of controlling the problem has been developed. A “temporary near term” solution was implemented and flown on SpX-6 in April 2015, as reported in 2015 (Reference: ICES-2015-155). See Figure 9 for a picture of a charcoal filter being assembled at KSC.

Because the modified Charcoal filters are considered an interim step that doesn't directly protect the five installed CCAA CHXs, a long term goal is to scrub the USOS atmosphere to eliminate or reduce CCAA CHX exposure to the PDMS contaminants by installing combined charcoal/HEPA filters, called the Integrated Charcoal HEPA (CHEPA) Filter Assembly, directly ahead of each installed CCAA CHX, located in the U.S. Lab, Airlock, Node 2 & Node 3.

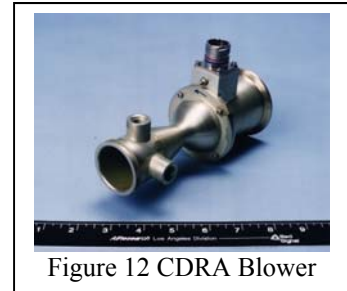
During the course of 2017, an effort has been made to gain some extra performance from the CDRA Blower in order to help support future 7 crew operations. The goal is to support CO₂ removal for larger crew compliments using a single operating CDRA. Stress and containment analysis was completed to demonstrate that the blower could be safely operated up to 150kRPM (110kRPM is the maximum spec speed). On-orbit tests were conducted using both the Node 3 and Lab CDRA. While the blower itself is capable of operating at the higher speed, the tests proved that additional operational & control hurdles exist to achieve the desired 150kRPM.

The US Lab CDRA blower successfully ran up to maximum speed of 139kRPM on HC1 and 142kRPM on HC2, while the Node 3 CDRA reached 133.4kRPM on HC1 and 141kRPM on HC2. The year, 2017, ended with on-going ground testing at MSFC using a development Pump Fan Motor Controller (PFMC) to determine if the controller or software is limiting further speed increases.

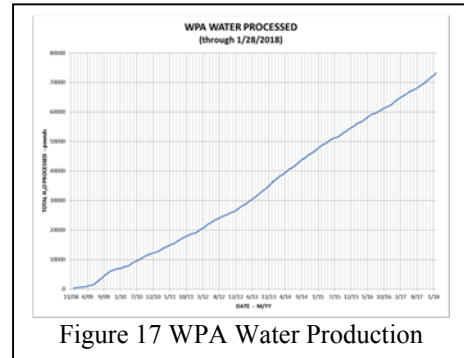
Figure 17 WPA Water Production

As of January 30, 2018 the USOS Water Processor Assembly (WPA) has processed 33,424 kg (73,533 lbs.) of water on ISS. The UPA has provided 15,255 kg (33,561 lbs.) of distillate, and the rest (18,177 kg (39,991 lbs.)) has been combined condensate + Contingency Water Collection (CWC) bag transfers, and includes approximately 1,064 kg (2,342 lbs.) of Sabatier product water.

To date the WPA has processed almost 10 times its hardware weight in water proving that the investment in regenerative water processing systems for ISS has been worthwhile. Accumulated water production through January 2018 is shown in Figure 17.
