WPA Mk I: On orbit and on ground investigations and refurbishment activities

This paper describes the flux of on orbit and on ground investigations that have involved the Water Pump Assembly (WPA) Mk I, from the issue detection to the identification of the subsystem involved, until the detailed investigation of the causes and the WPA refurbishment and re-acceptance.

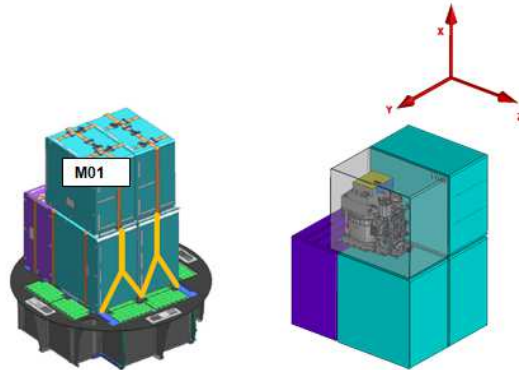
Figure 5: WPA Accommodation

The WPA would be returned with SpX3, inside a bag, soft stowed. In this configuration, the risk of a potential damage during descent was real because the WPA was designed and qualified for flying in hard mounted condition: this condition was therefore the only certified transportation configuration in which WPA design safety could be considered robust & reliable. Moreover additional static analyses simulating the new transportation condition could not be performed, due to the unavailability of a WPA Finit Element Model (FEM). Because of its big dimensions (608.83 x 409.73 x 831.92 mm) and huge mass (about 80 kg), the WPA has been packed inside a (M01) bag and with the Launch Authority it was decided to accommodate the bag in the Central stack of Dragon Pressurized Compartment (see Figure 5).

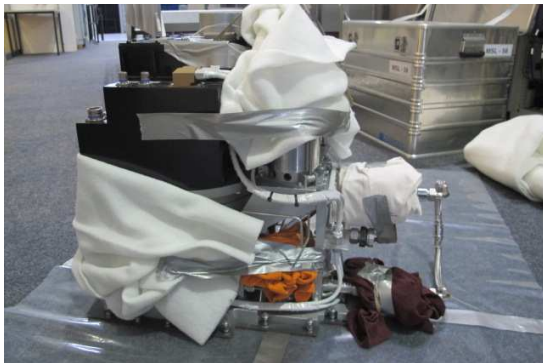
Figure 6: T-shirts placement (in contact with delicate parts of WPA)

TAS-I support was requested to identify the more critical areas of the pump and suggest possible work-arounds to mitigate and contain the risks of a WPA2 structural failure. To evaluate the foam pressures induced from the vehicle on the WPA inside the strapped bag, a general strength assessment, based on simple methods, was performed, by using all the phase C/D documentation. The assessment, while confirming the general WPA mechanical compatibility vs. Dragon requirements, highlighted some potential criticalities relevant to the WPA Quick Disconnect (QDs), sensors and piping: if the WPA flew in wet condition, potential leakage could not be excluded and the expected leakage would be in the order of 6 liters.

Consequently, it was necessary to assure an appropriate packaging in order to limit, as much as possible, the leakage inside Dragon Compartment: all the sensors, piping and delicate parts of WPA should avoid contact with the foam. For the final packaging, in addition to the foam, the astronauts used also absorbent materials (dry wipes/T-shirts, see Figure 6).

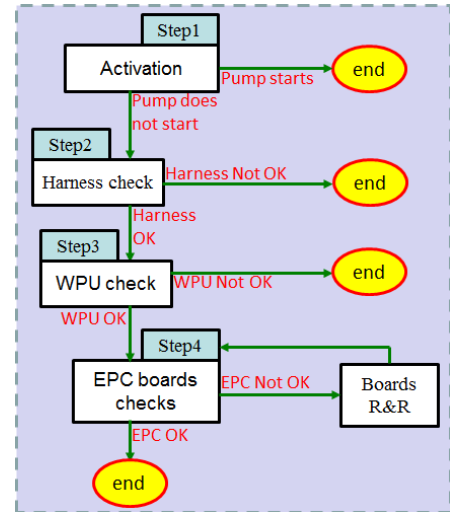
Figure 7: Troubleshooting Plan

The first phase implied high level functional checks just to either exclude or confirm the problem in the specific item object of the check. The activity was divided in 4 sequential steps: Step 1 – Activation, Step 2 – Harness check, Step 3 – WPU check, Step 4 – EPC boards check (see Figure 7).

The sequence of the checks was conceived to identify unambiguously in which part of the assembly the problem had arisen, in particular discriminating between motor (WPU) or electronic box (EPC) that were the most likely candidates. The tests were performed using standard laboratory electrical instrumentation and a ground DMS Emulator to simulate the Columbus DMS for command sending and telemetry acquisition. The 4 steps will be described in detail hereafter.

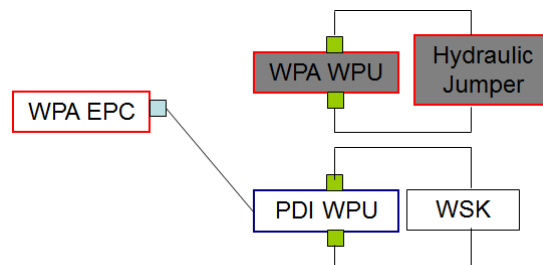
Figure 8: Step4 Test Set-up

In order to confirm or exclude a failure at WPU or EPC level, a Pre-integrated Development Item (PDI) model of the WPA was introduced in the test set-up. The PDI is a ground development assembly that reproduces exactly in terms of interfaces and components the flight WPA, allowing to test potentially failed flight WPU and EPC using functioning WPU and EPC of the PDI. This was done cross-connecting flight and ground items and commanding the activation of the impeller. In particular, in Step 3 the flight WPU was checked connected to the PDI-EPC (see Figure 9) and in Step 4 the flight EPC was tested connected to the PDI-WPU (see Figure 8).

Practically the test of Step 3 was the same as that of Step 1, with the only difference that the EPC was not the flight one but the PDI one. In this configuration, the flight WPU could be commanded with a working EPC allowing to immediately establish if the motor had failed or not. The outcome of the test was positive in the sense that the flight WPU started running when commanded through the PDI-EPC. Telemetries were also in line with expected data considering the jumper closed loop configuration. This allowed to exclude a WPU electrical problem and to locate the failure definitely in the flight EPC.
