Coolant Leak from ISS External Active Thermal Control System (EATCS) – An Examination of Most Probable

Darnell T. Cowan¹, Timothy A. Bond²

NASA Lyndon B. Johnson Space Center, Houston, TX, 77058

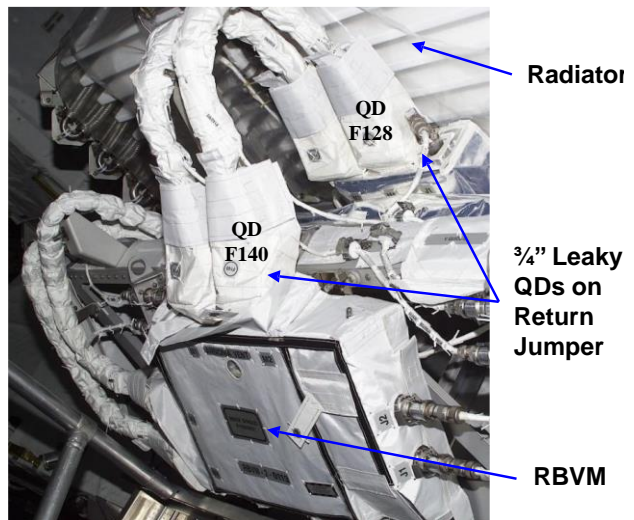
Figure 1. Radiator Jumper connected to a radiator and the Radiator Beam Valve Module (RBVM) that control flow to and from the radiator

Both the supply and return radiator jumpers were refurbished, launched, and reinstalled during an Extravehicular Activity (EVA), or spacewalk which occurred in March 2022. There are over two hundred similar QDs as part of each the S1 and P1 EATCS, and twenty-four are of same type and size as the QDs on the return jumper that was found to be leaking. Understanding the failure that caused QD F128 to leak and determining if it was unique or common to the other QDs was important to assess the long-term sustainability of the EATCS. This paper discusses the findings, conclusions, recommendations, and observations from this failure investigation.
